**VILLAGE OF SOUTH RUSSELL
GEAUGA COUNTY, OHIO**

MASTER STORM STUDY

**CT Consultants, Inc.
8150 Sterling Court
Mentor, Ohio 44060**

June 2021

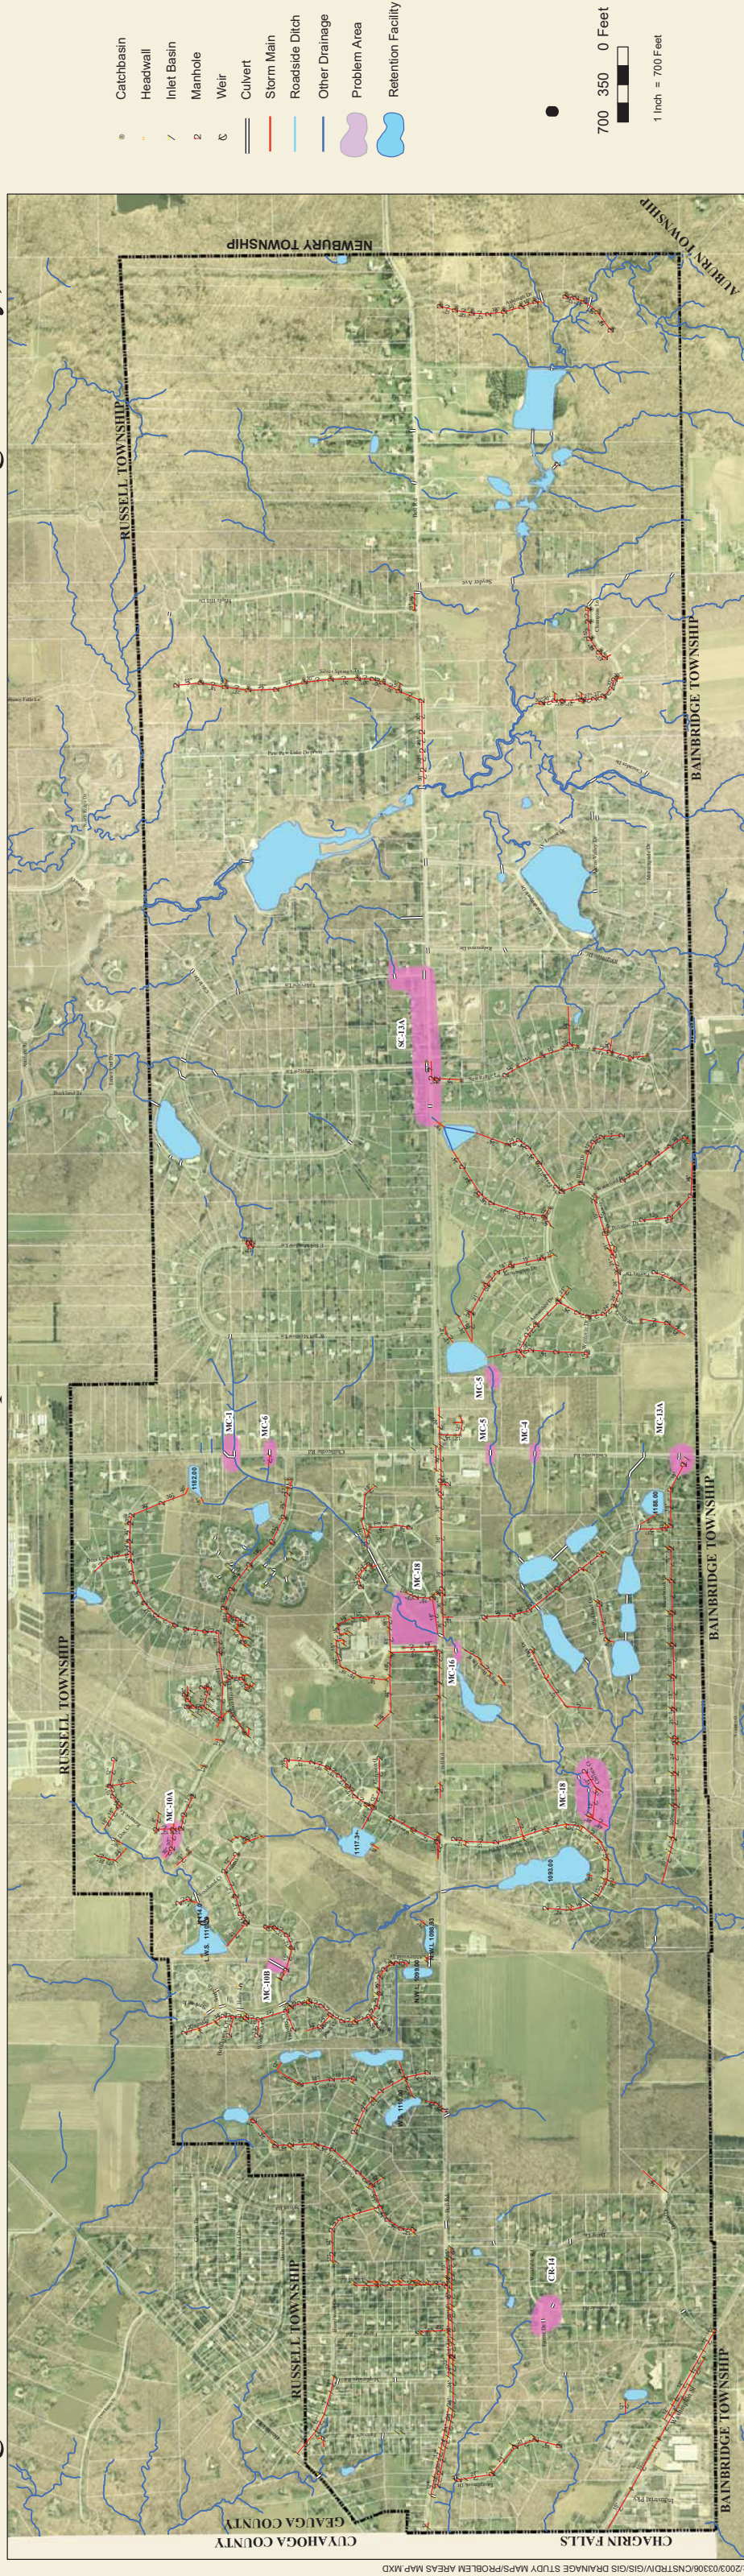
Figure 2

The following areas as identified above as deficient merit further discussion. The information is presented in order of perceived importance to the community. **Figure 2** is an overall map of the Village illustrating the location of each of the areas as described below.

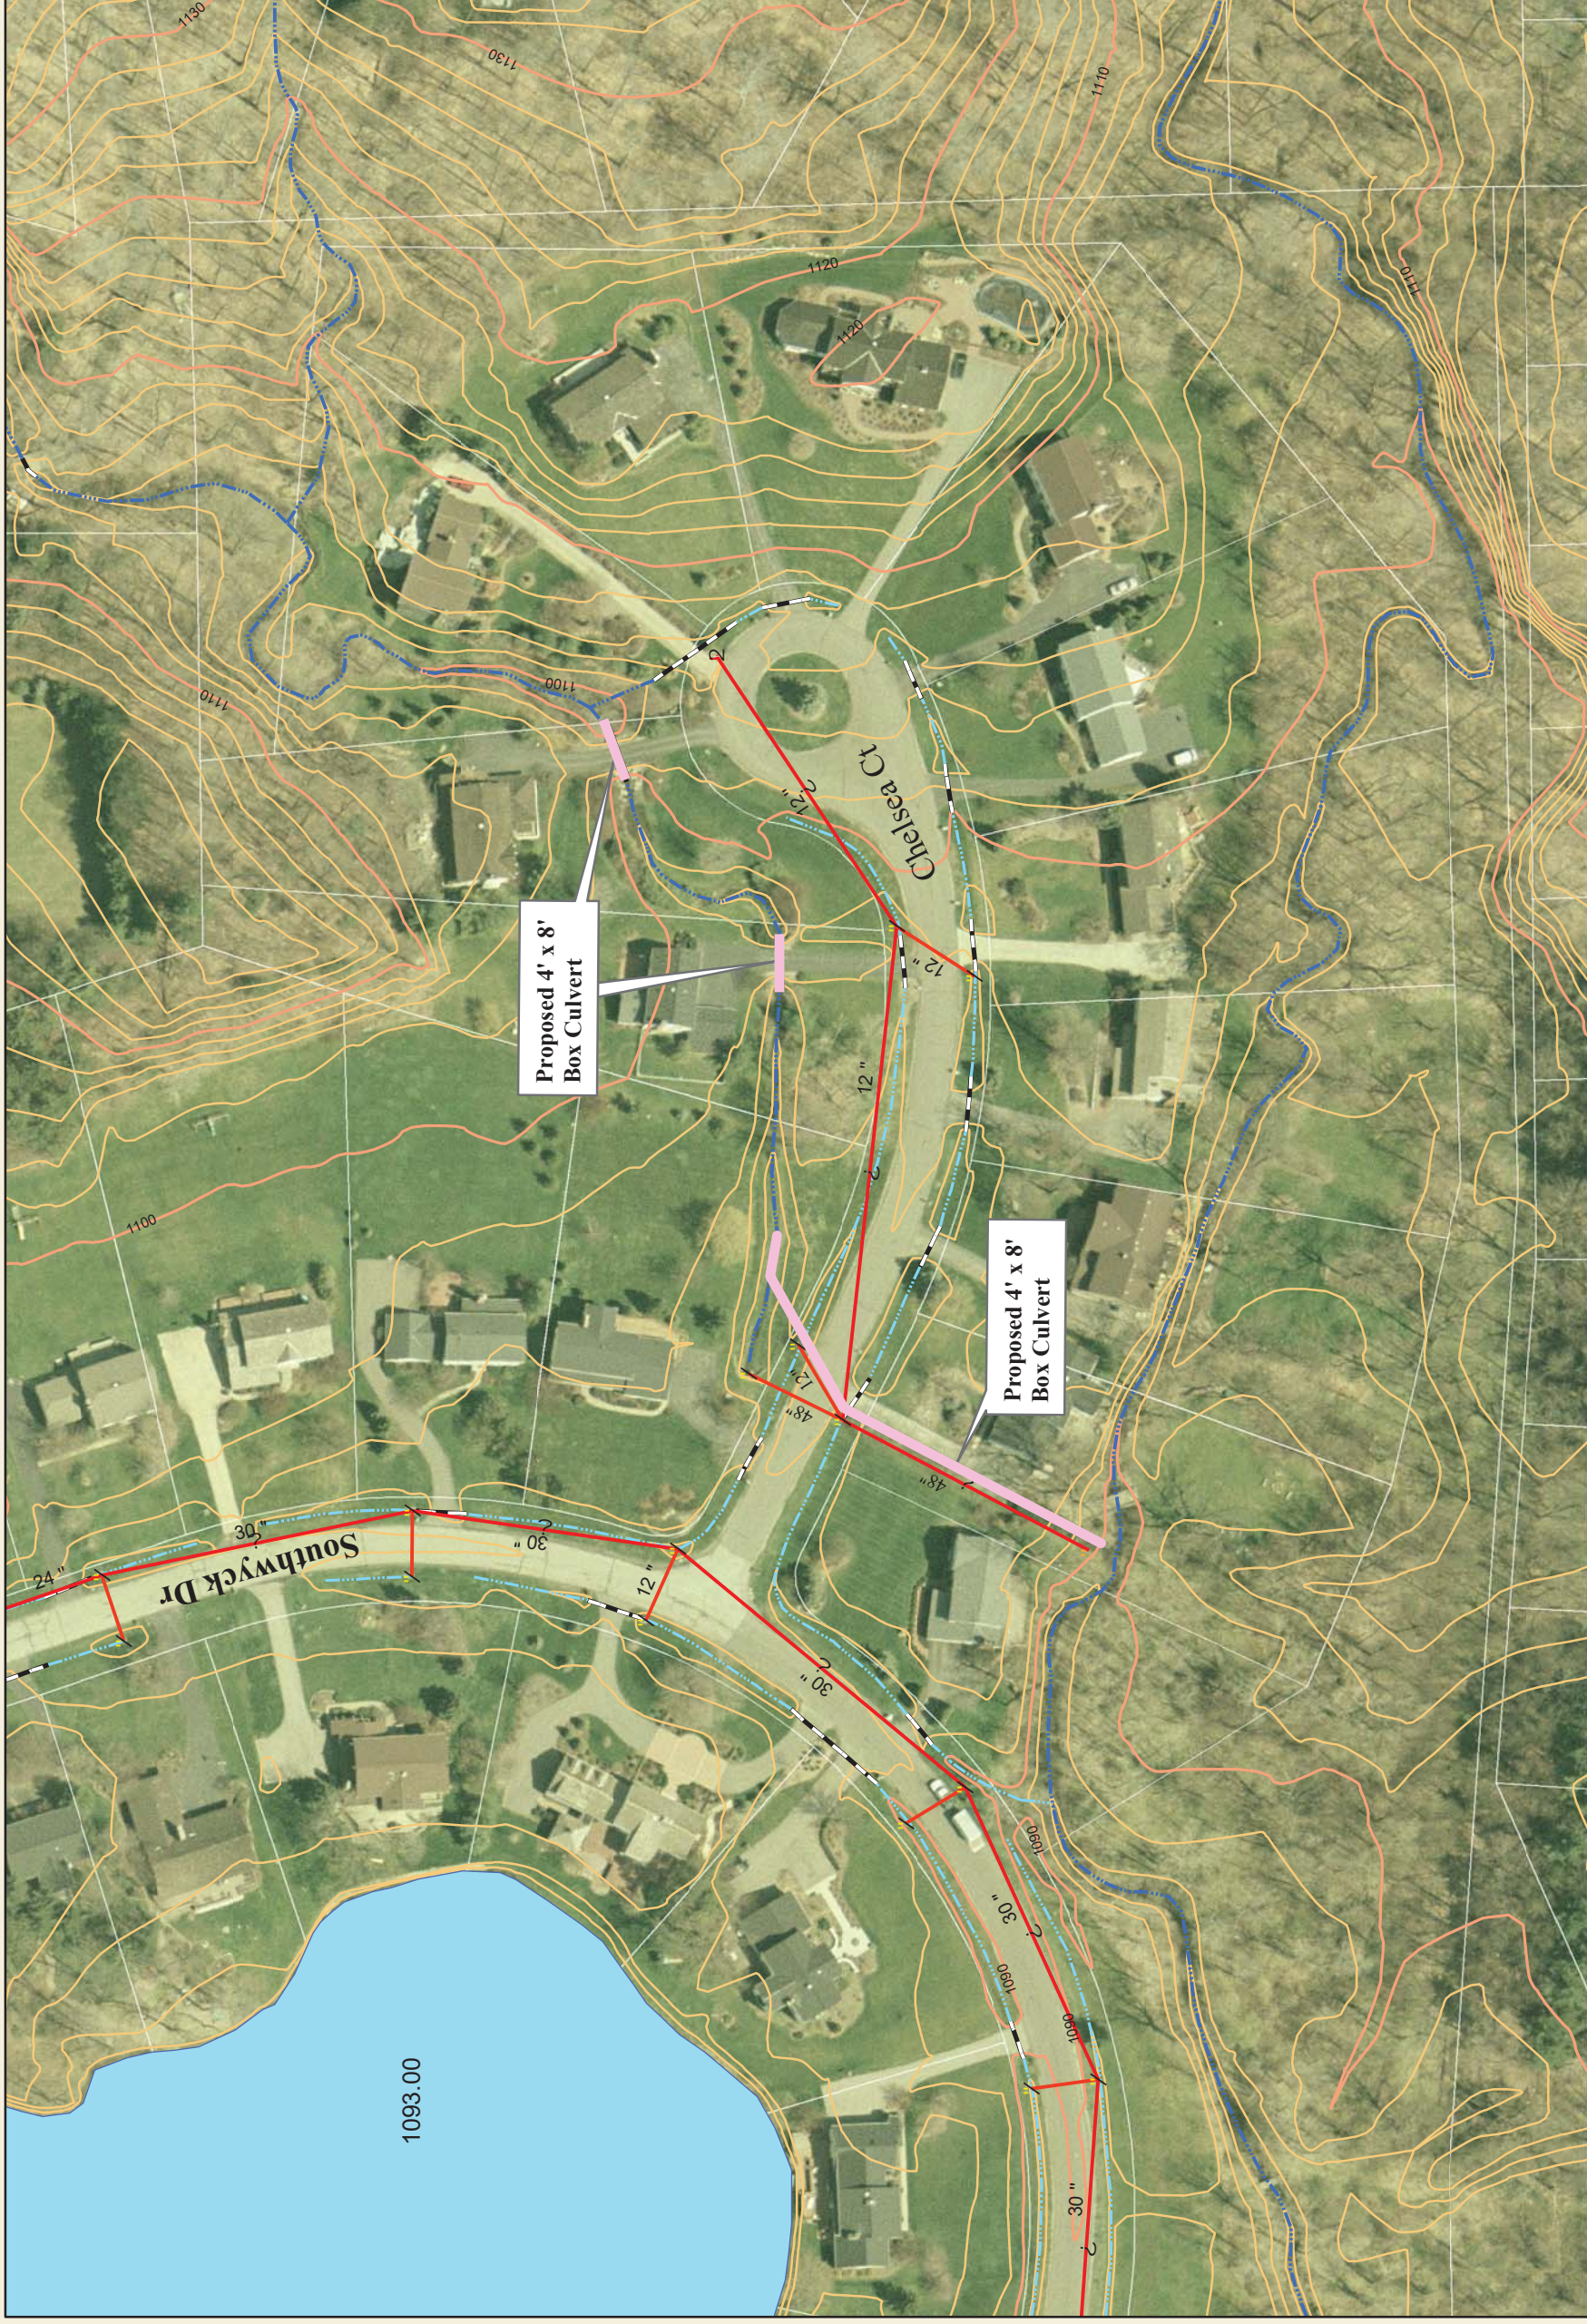
MC-18 DRAINAGE PROBLEM, ALTERNATIVE 1

Project Data

Drainage Area = 336 Acre
 Peak Flow, 25 Yr = 273 cfs
 Existing Capacity = 151 cfs
 Estimated Project Cost = \$440,500

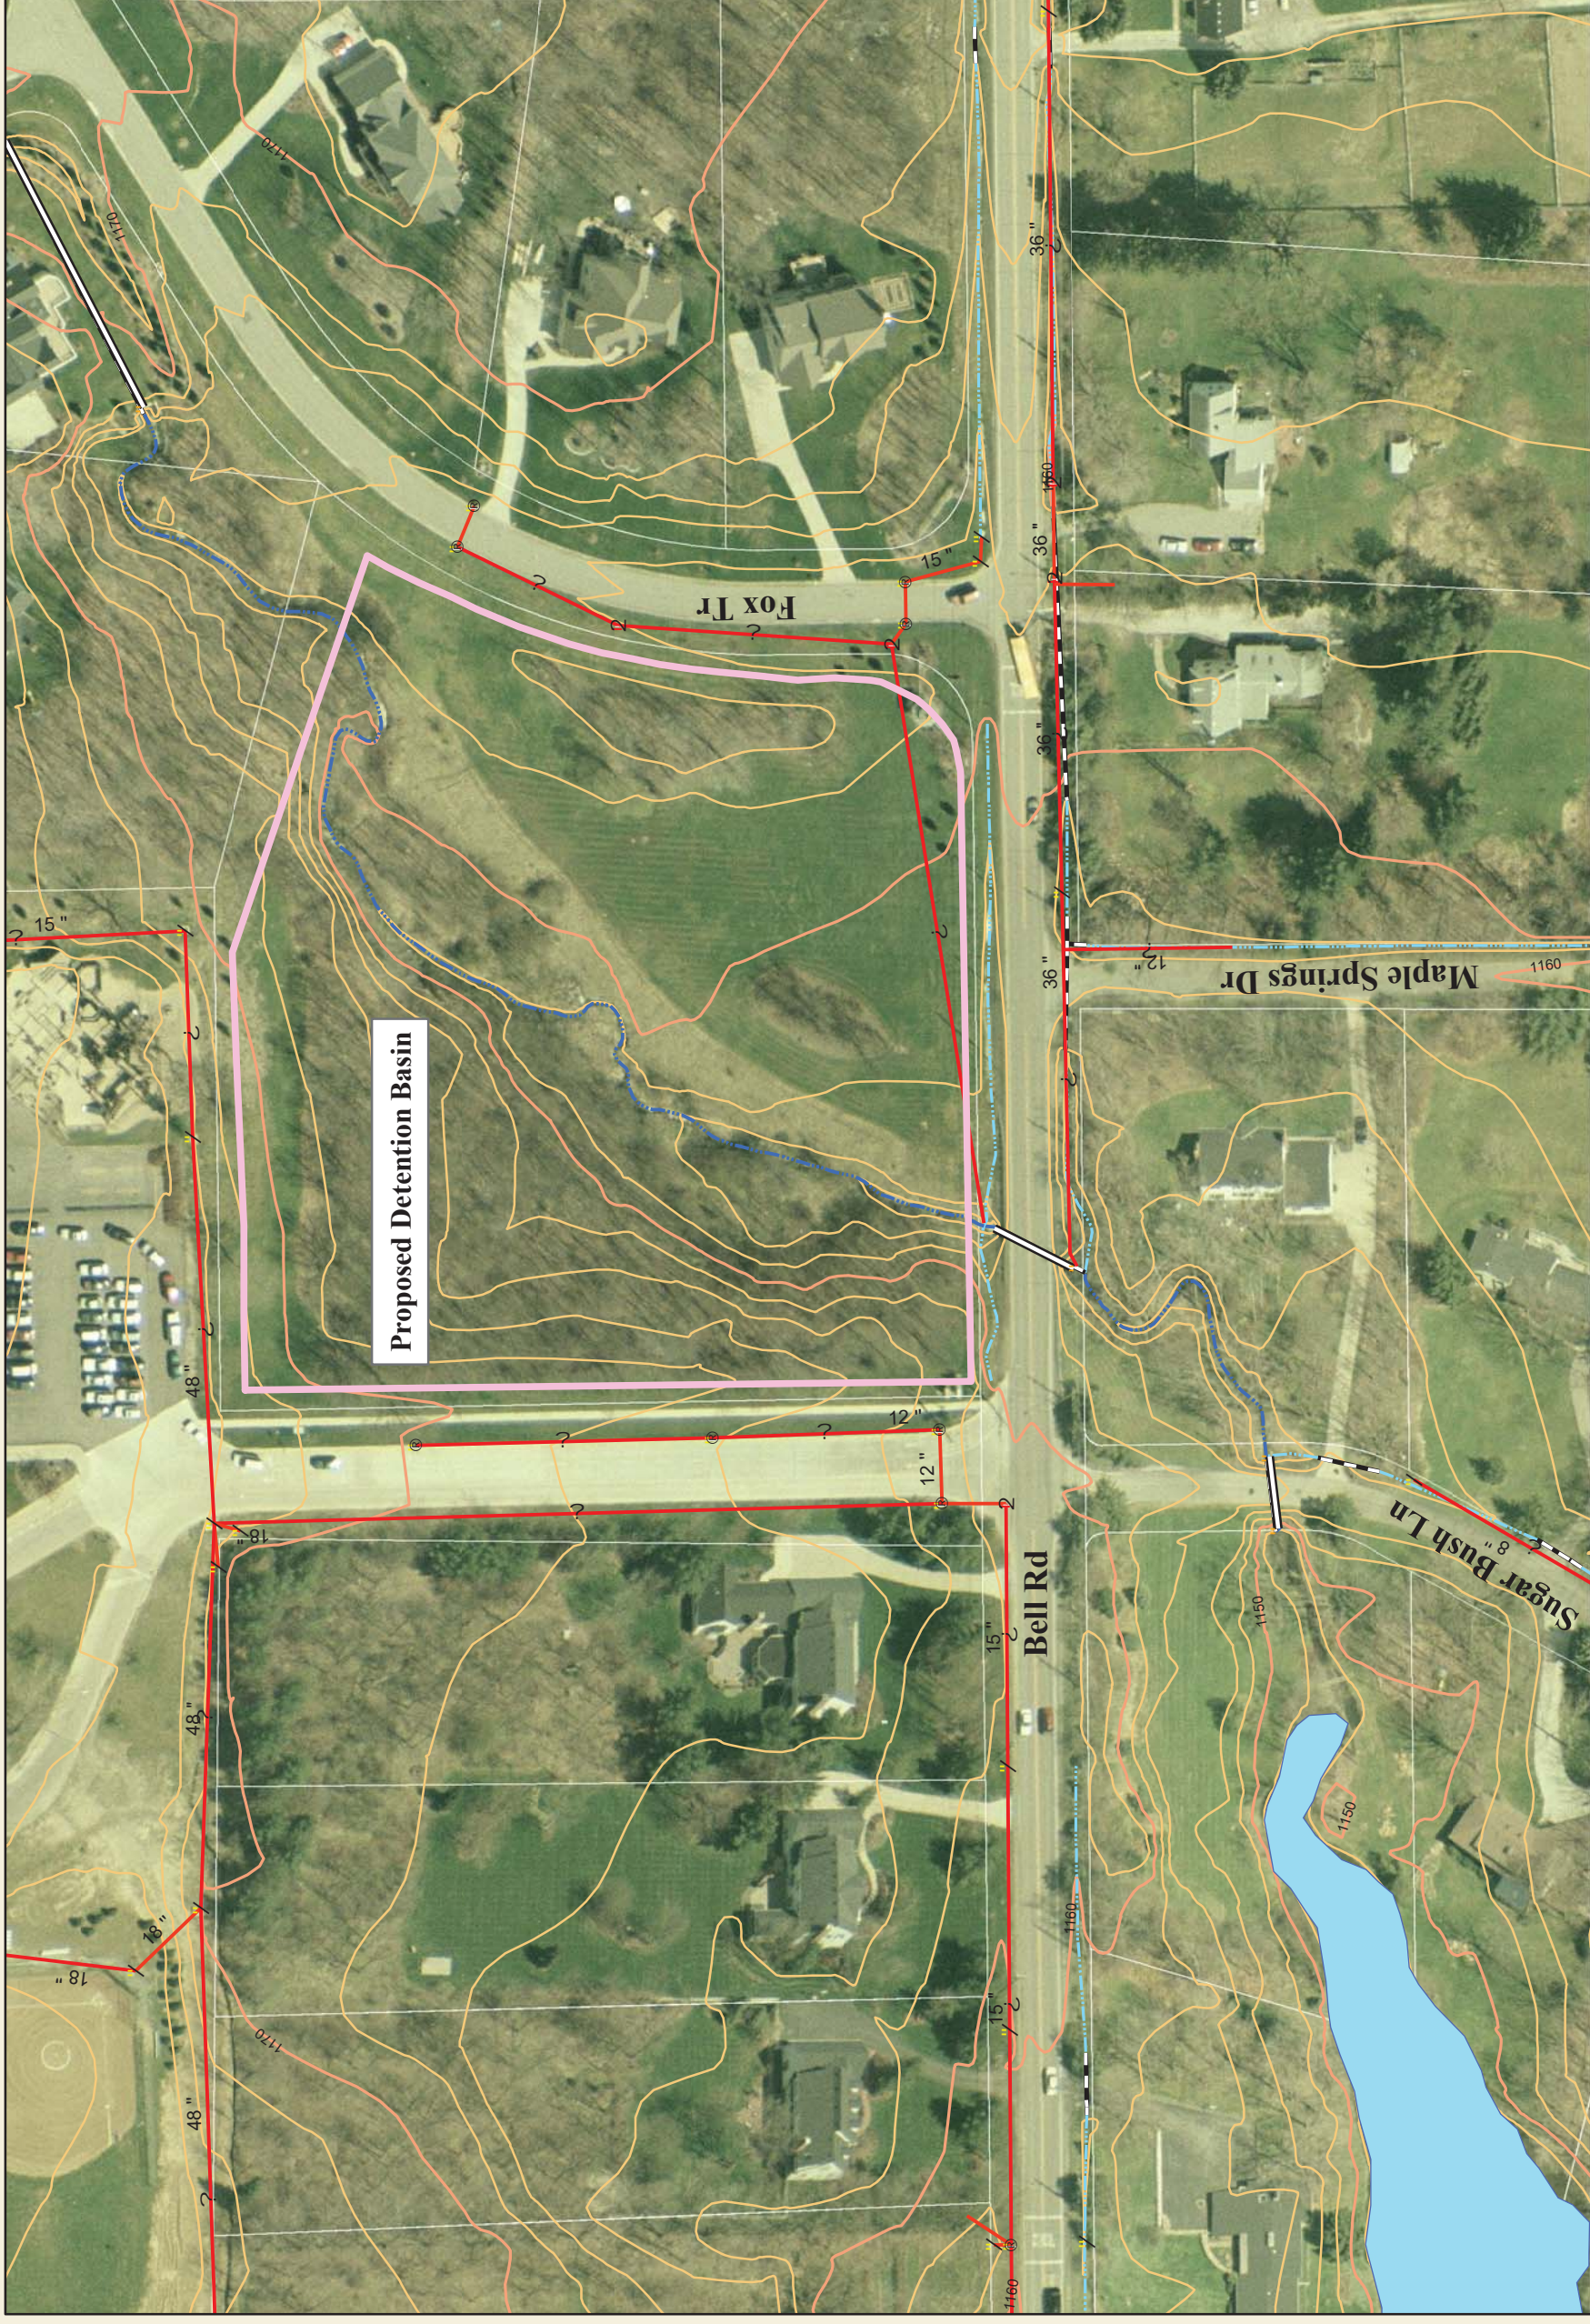
MC-18 DRAINAGE PROBLEM, ALTERNATIVE 2

Project Data

Drainage Area = 272.5 Acre
 Peak Flow, 25 Yr = 205 cfs
 Peak Flow at Chelsea, 25 Yr = 158 cfs
 Existing Capacity at Chelsea= 151 cfs
 Estimated Project Cost = \$684,500

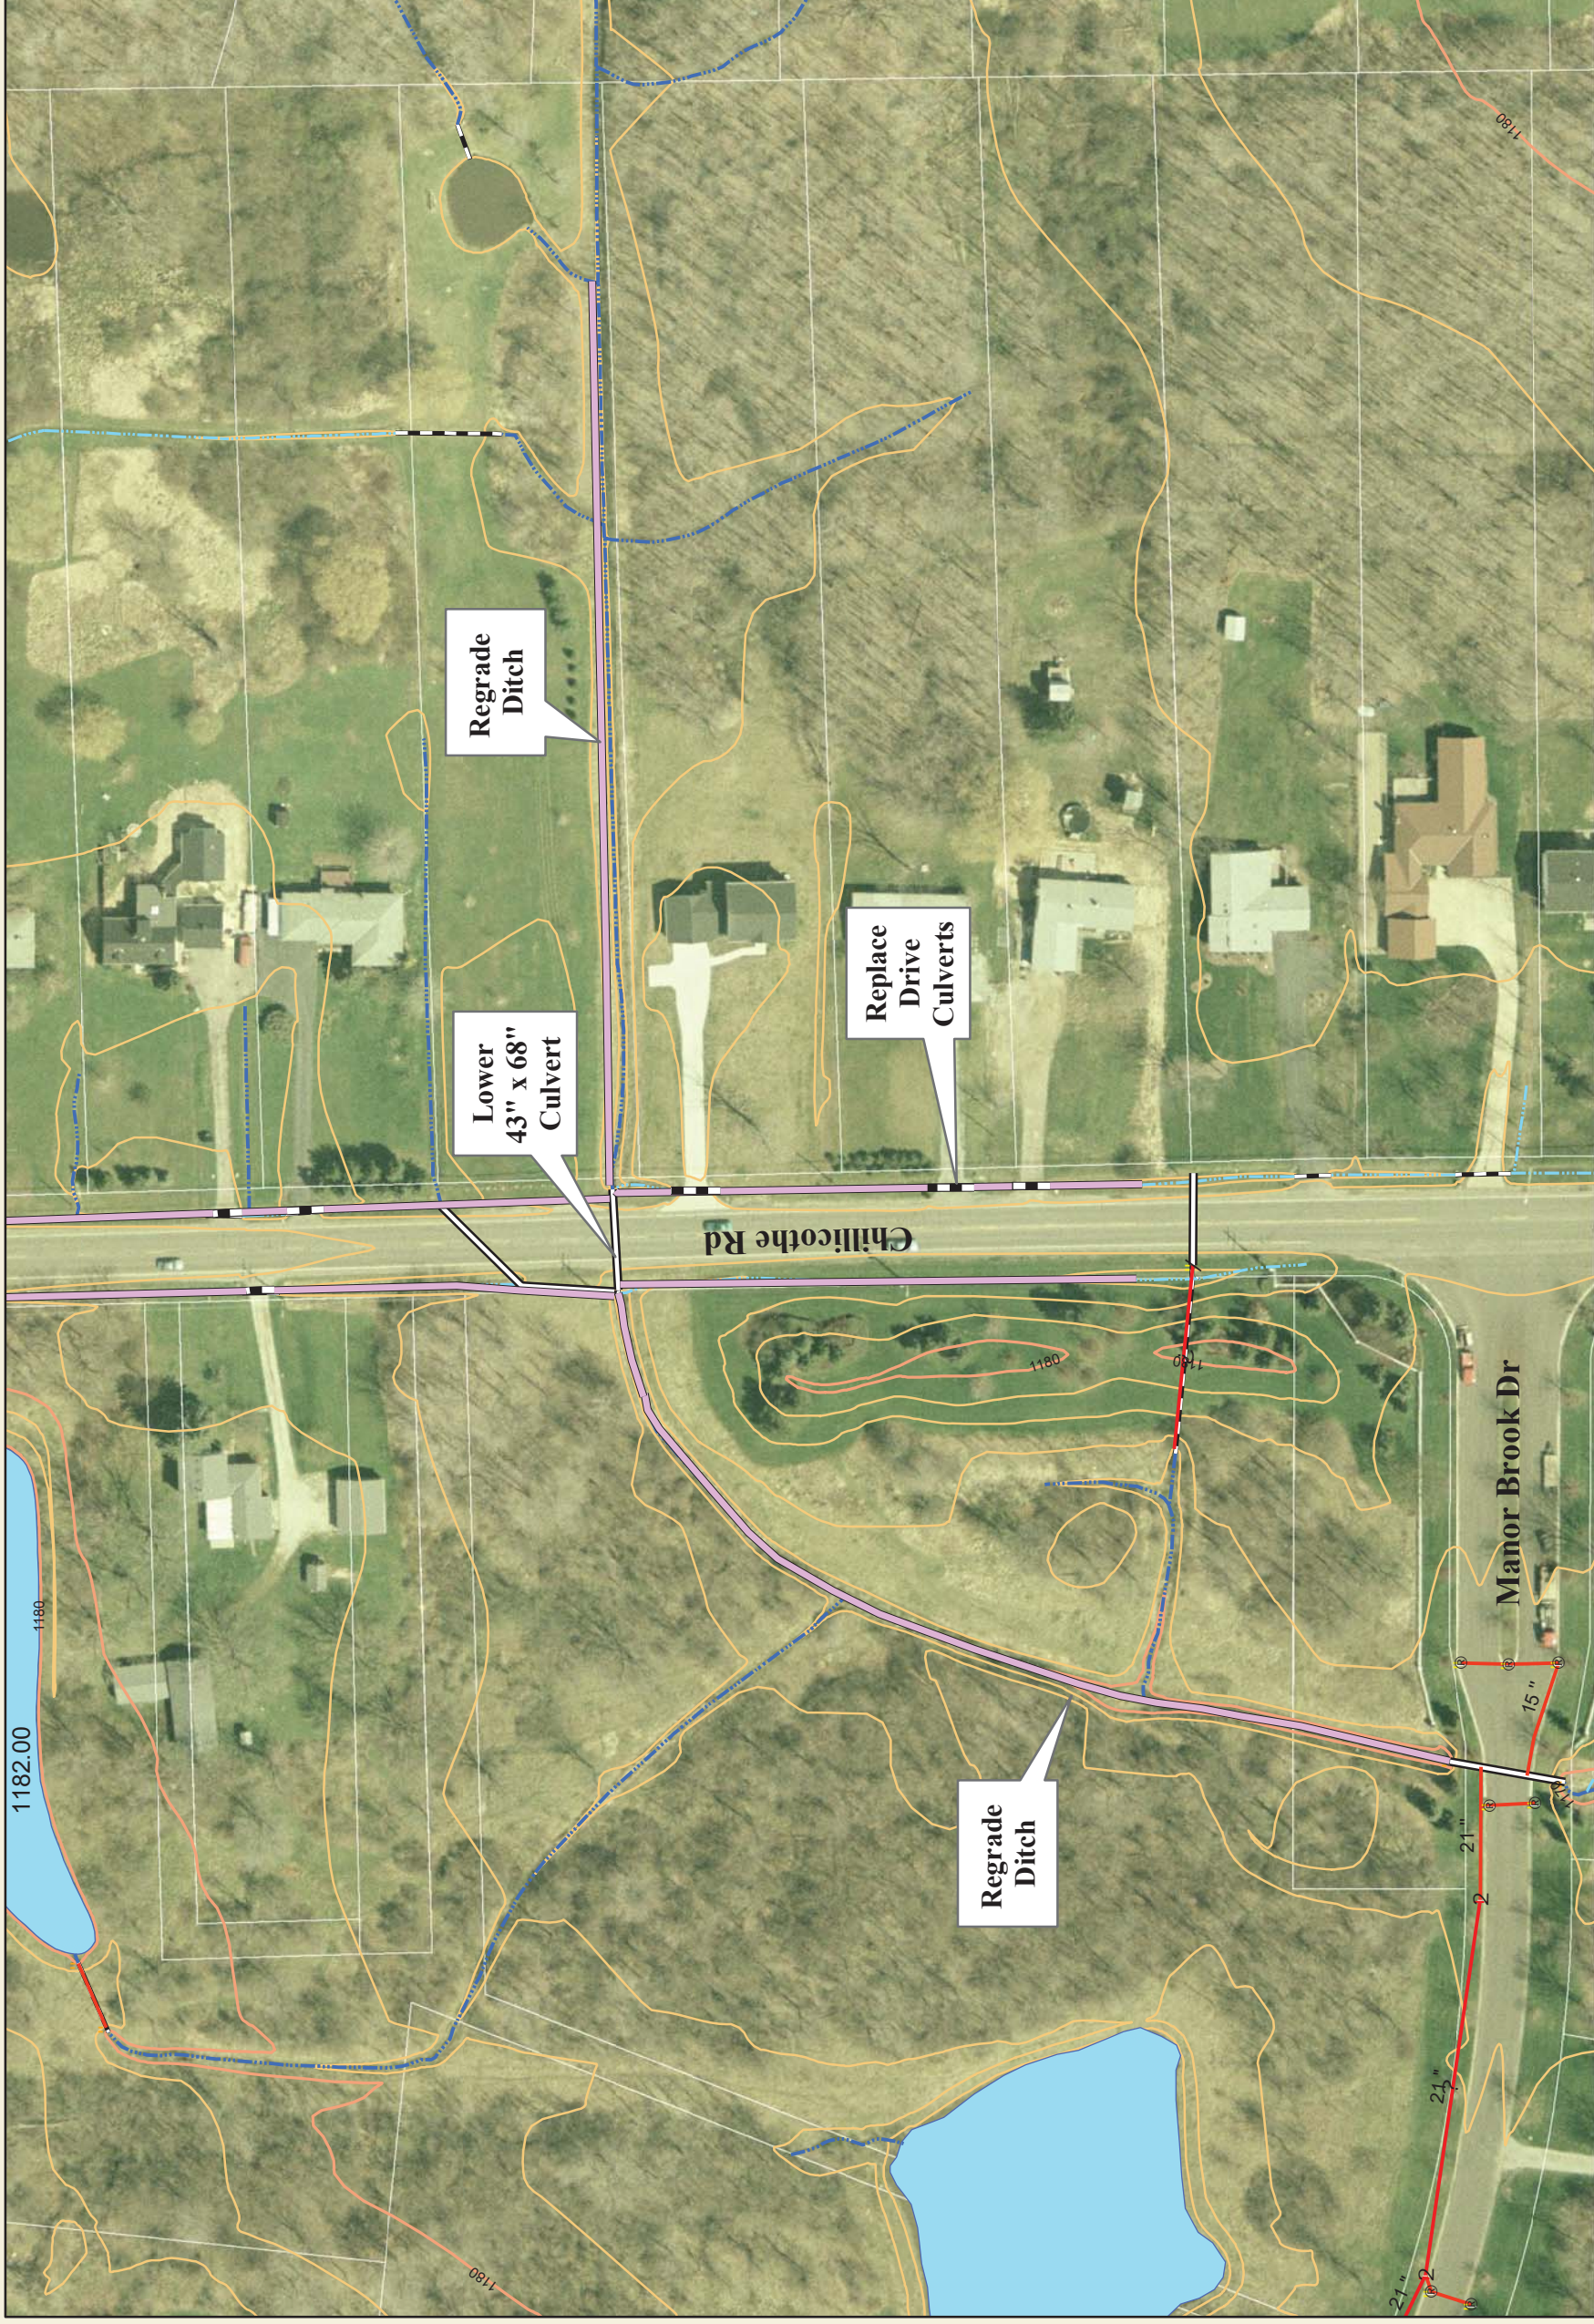
Project Data

Drainage Area = 119 Acre
 Peak Flow 25 Yr = 80 cfs
 Existing Capacity = 171 cfs
 Estimated Project Cost = \$277,000

Although the existing culvert has the capacity to pass the flow generated by a 25 year storm, there is reported flooding in many of the low-lying yard areas in the vicinity of this culvert. It would appear that the problem is not the culvert itself, but the ability for the water to get to the culvert.

A possible solution would be to regrade the drainage swale downstream of Chillicothe Road thereby developing/restoring floodplain stormwater storage in the Manorbrook Road area. The Village was successful in garnering EPA 319 Grant funds to implement this project, and is currently in the process of acquiring the necessary drainage easements prior to construction. See **Figure 5** for a drawing of the proposed improvements.

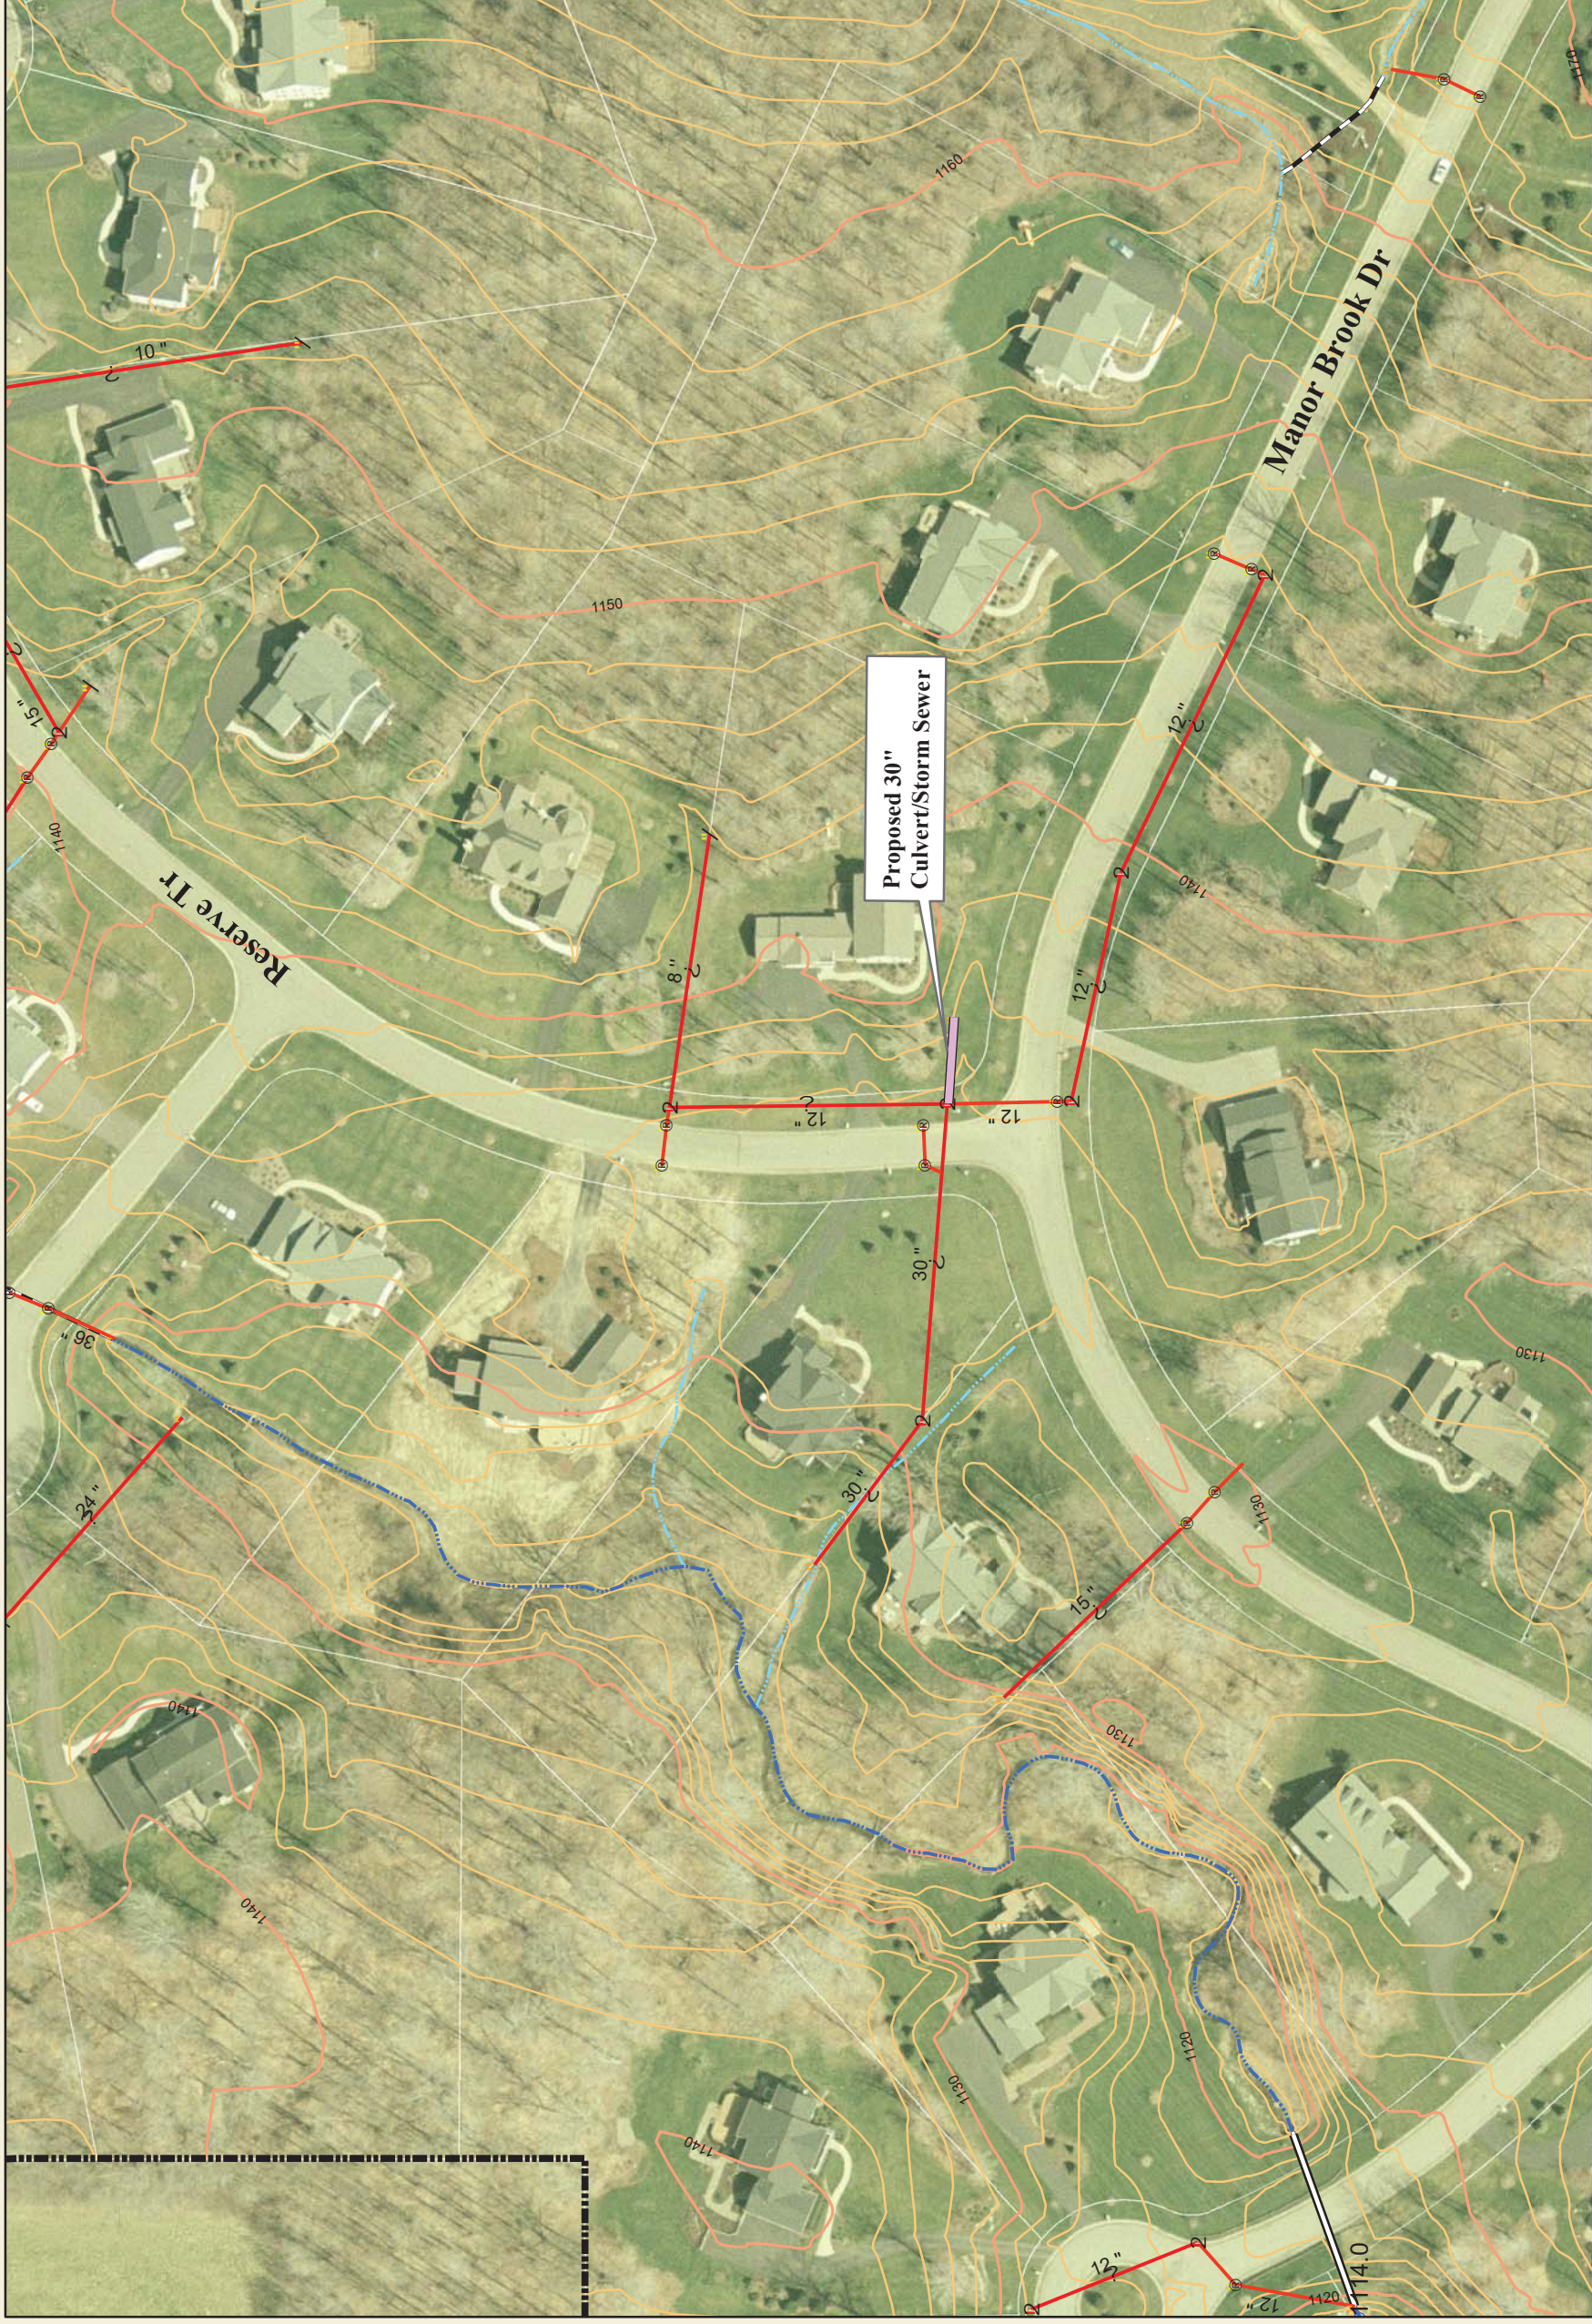
Project Data

Drainage Area = 29 Acre
Peak Flow, 25 Yr = 35 cfs
Existing Capacity = 25 cfs
Estimated Project Cost = \$32,250

The roadway culvert which consists of a 24” pipe under the pavement and a 30” pipe beyond the pavement between house #506 and house #508 located at the intersection of Manorbroom Drive and Reserve Trail has been found to have the capacity for the peak flow generated by a 5 year storm. This is less than the 25 year criteria used for roadway culverts.

A possible solution to the problem would be to increase the size of the culvert to pass the calculated peak flow without overtopping the road. This would involve replacement of the existing 24” culvert with a 30”culvert on a same alignment. Presumably, the existing permanent easements for the 24” culvert can be utilized for this option. See **Figure 7** for a drawing of the proposed improvements.

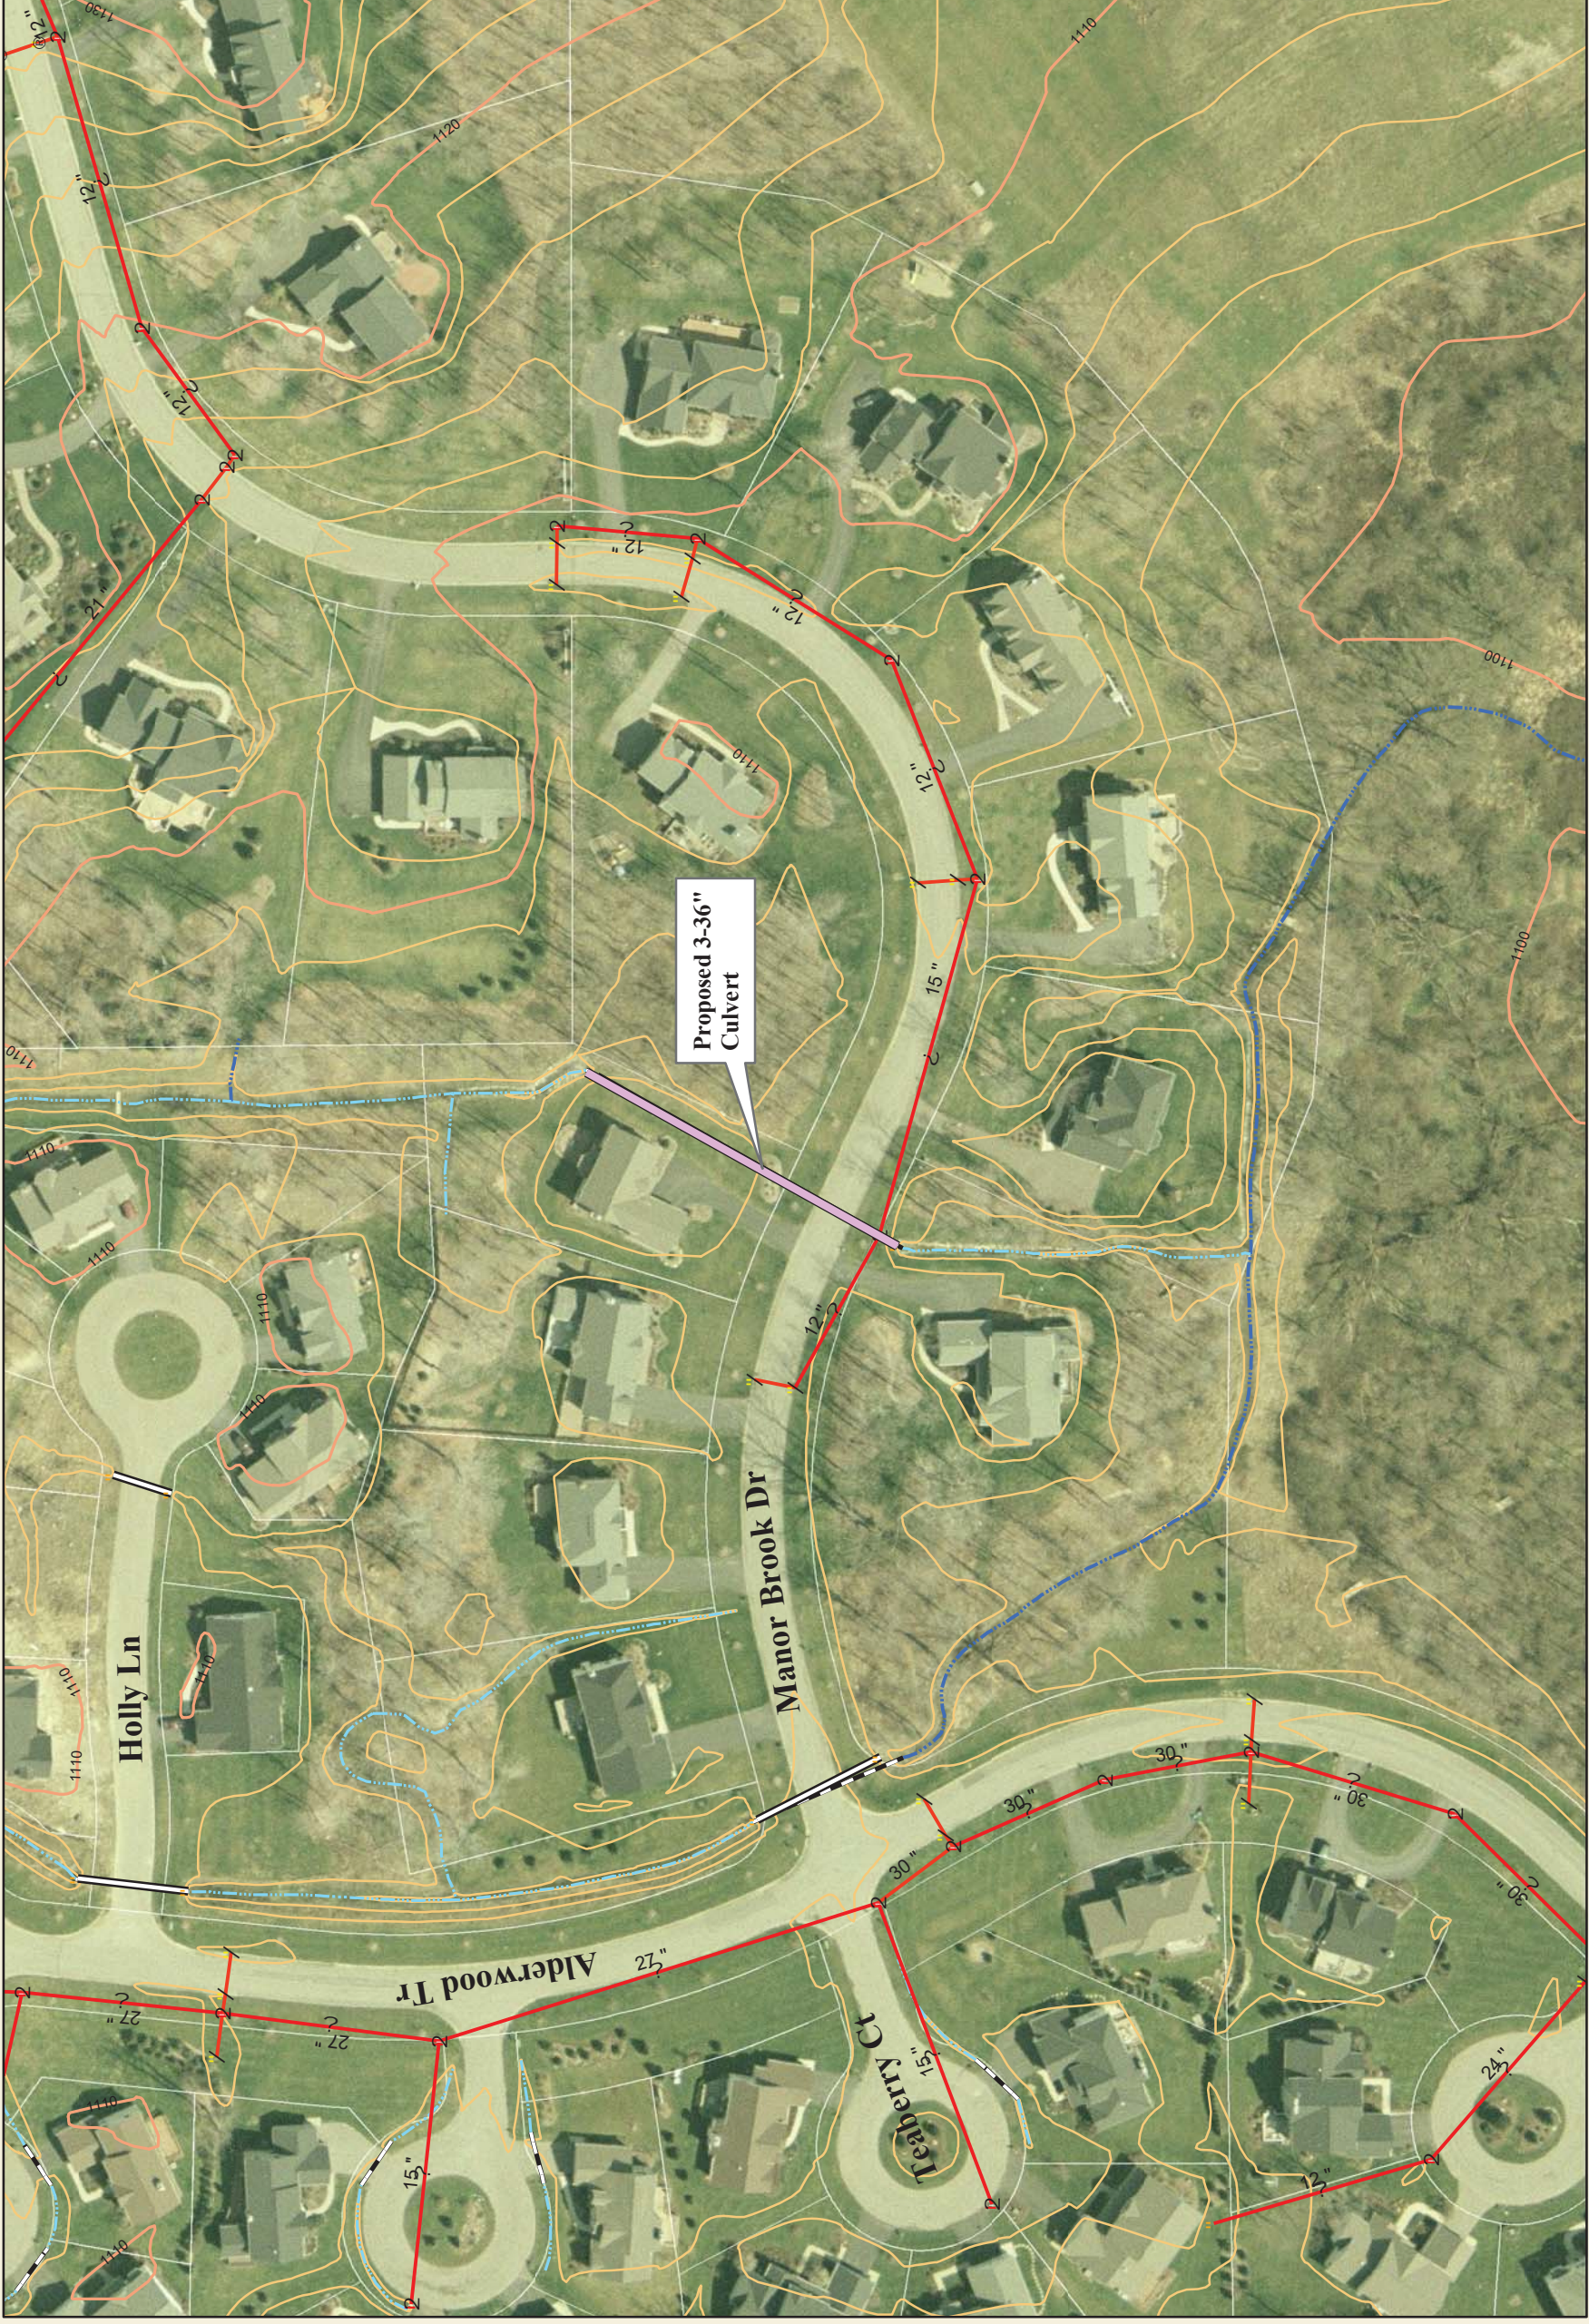
Project Data

Drainage Area = 143.7 Acre
Peak Flow, 25 Yr = 155 cfs
Existing Capacity = 64 cfs
Estimated Project Cost = \$129,560

The 36” roadway culvert on Manorbrook Drive, approximately 400 feet east of Alderwood Trail has been found to have the capacity for the peak flow generated by a 2 year storm. This is far less than the 25 year criteria used for roadway culverts.

A possible solution to the problem would be to increase the number of the culvert barrels to pass the calculated peak flow without overtopping the road. This would involve the addition of three 36” culverts in parallel, for a total of four, on a same alignment as the existing culvert. Due to pipe cover constraints, a single larger diameter pipe does not appear to be feasible at this site. Grading easements may be requires up and down stream of the work area to perform this work. See **Figure 8** for a drawing of the proposed improvements.
