**VILLAGE OF SOUTH RUSSELL
GEAUGA COUNTY, OHIO**

MASTER STORM STUDY

**CT Consultants, Inc.
8150 Sterling Court
Mentor, Ohio 44060**

June 2021

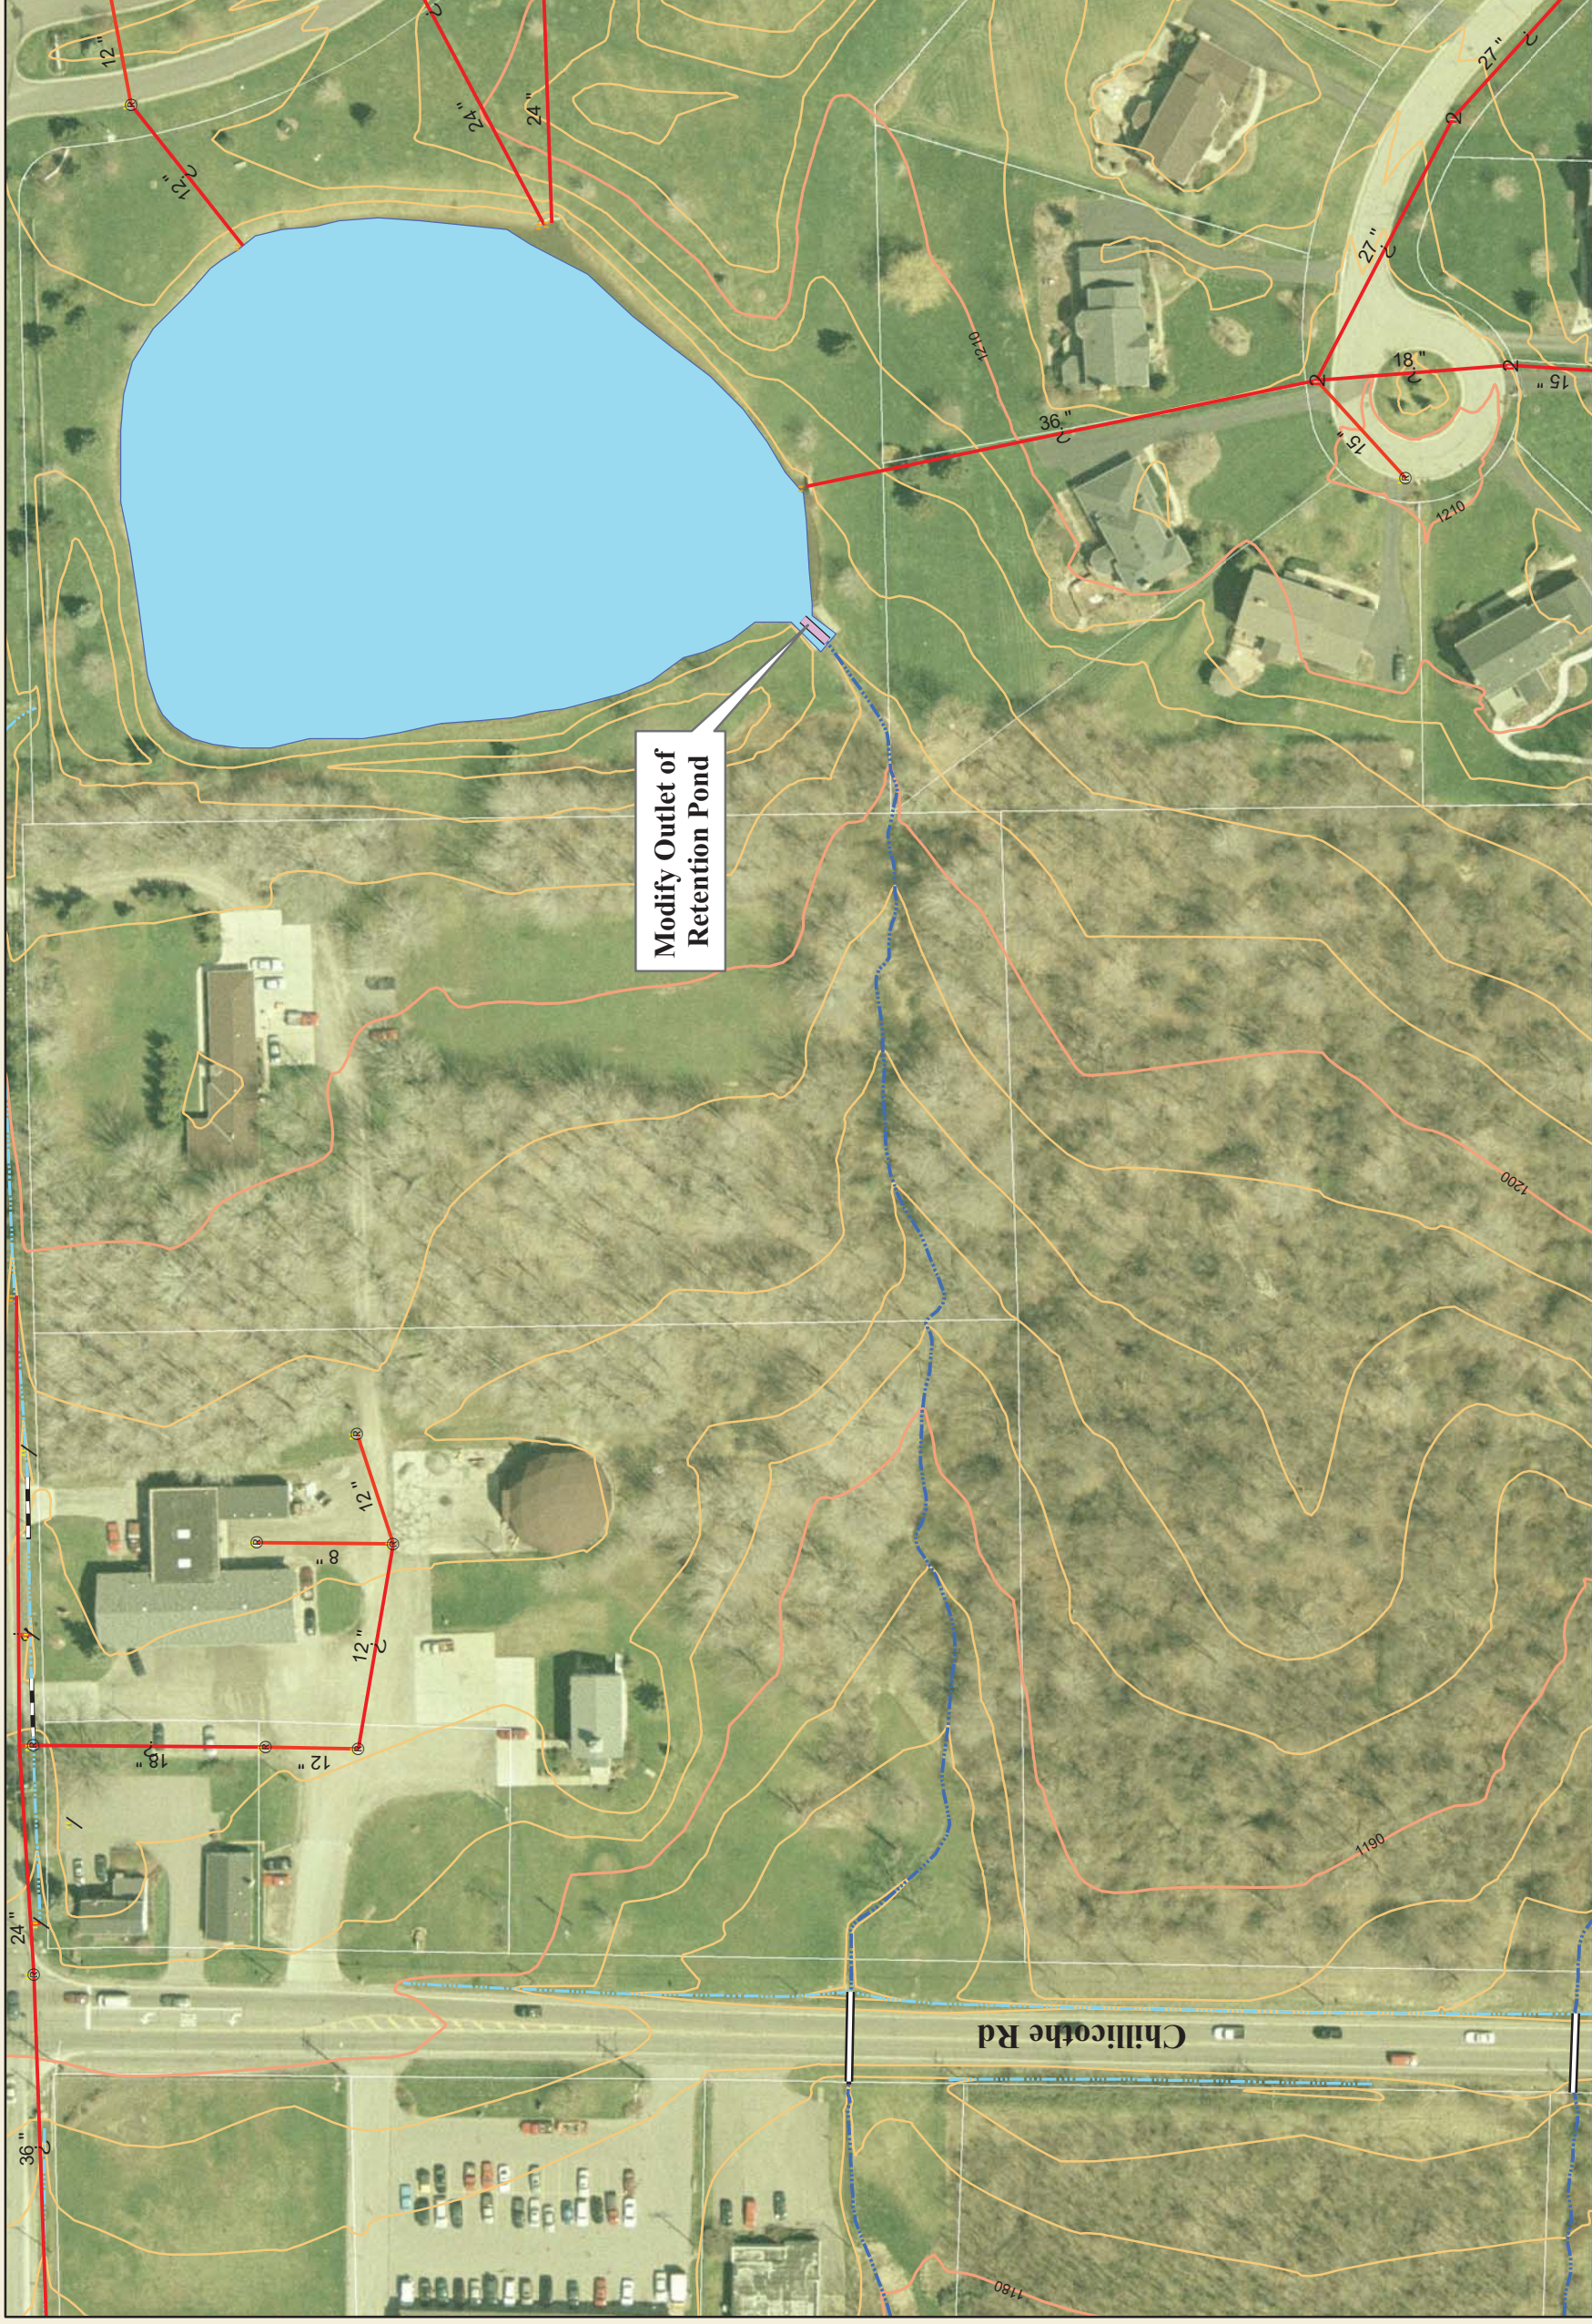
MC-5 DRAINAGE PROBLEM, ALTERNATIVE 1

Project Data

Drainage Area = 56 Acre
 Peak Flow, 100 Yr = 21 cfs
 Peak Flow at Chillicothe, 25 Yr = 15 cfs
 Existing Capacity at Chillicothe = 14 cfs
 Estimated Project Cost = \$48,100

The 15” roadway culvert on Chillicothe Road at this location has been found to have the capacity for the peak flow generated by a 2 year storm. This is far less than the 25 year criteria used for roadway culverts.

1. Construct New Retention Basin – This solution would involve the construction of a new Retention Basin on Village Property upstream of Chillicothe Road. This solution would be the preferable because downstream flows would be reduced and may offset any negative effects of implementing the proposed solution to the problem at location MC-4. See **Figure 9** for a drawing of the proposed improvements.

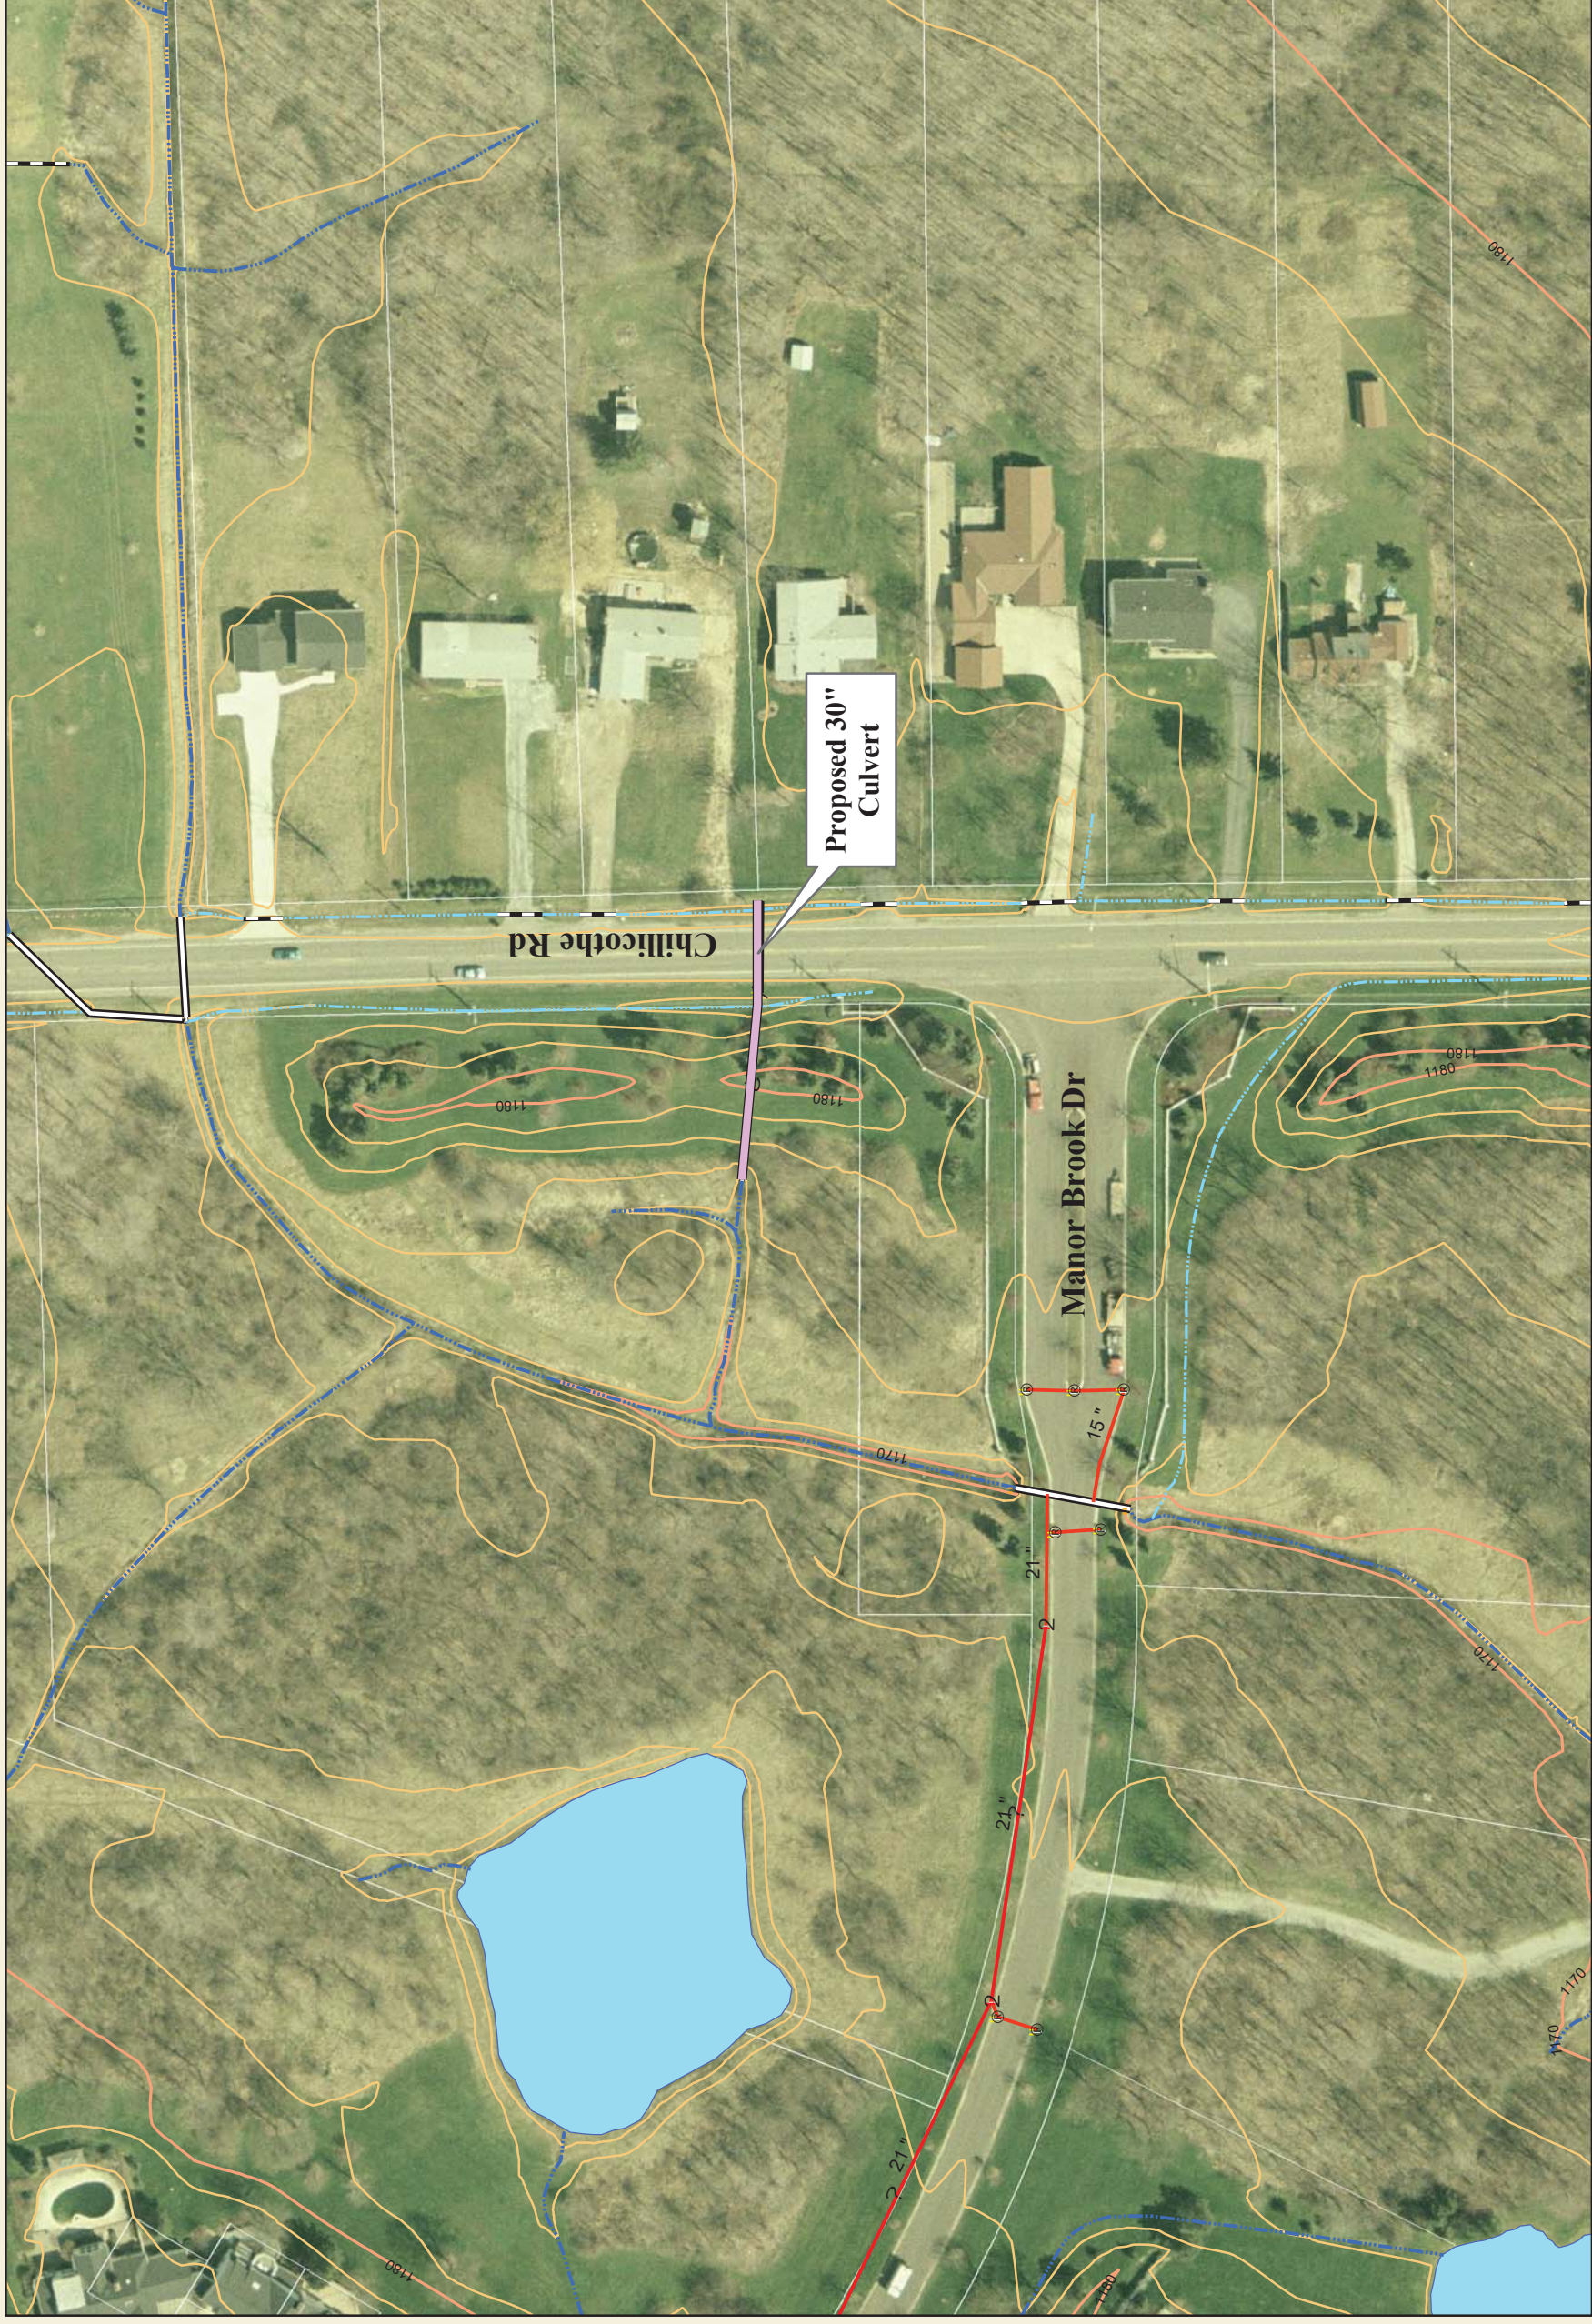
MC-6 DRAINAGE PROBLEM

Project Data

Drainage Area = 29 Acre
 Peak Flow, 25 Yr = 40 cfs
 Existing Capacity = 9 cfs
 Estimated Project Cost = \$47,650

The 12” roadway culvert on Chillicothe Road at this location has been found to have the capacity for the peak flow generated by a 1 year storm. This is far less than the 25 year criteria used for roadway culverts.

A possible solution to the problem would be to increase the size of the culvert to pass the calculated peak flow without overtopping the road. This would involve replacing the existing culvert with a 36” culvert. Grading easements may be required up and down stream of the work area to perform this work. See **Figure 11** for a drawing of the proposed improvements.

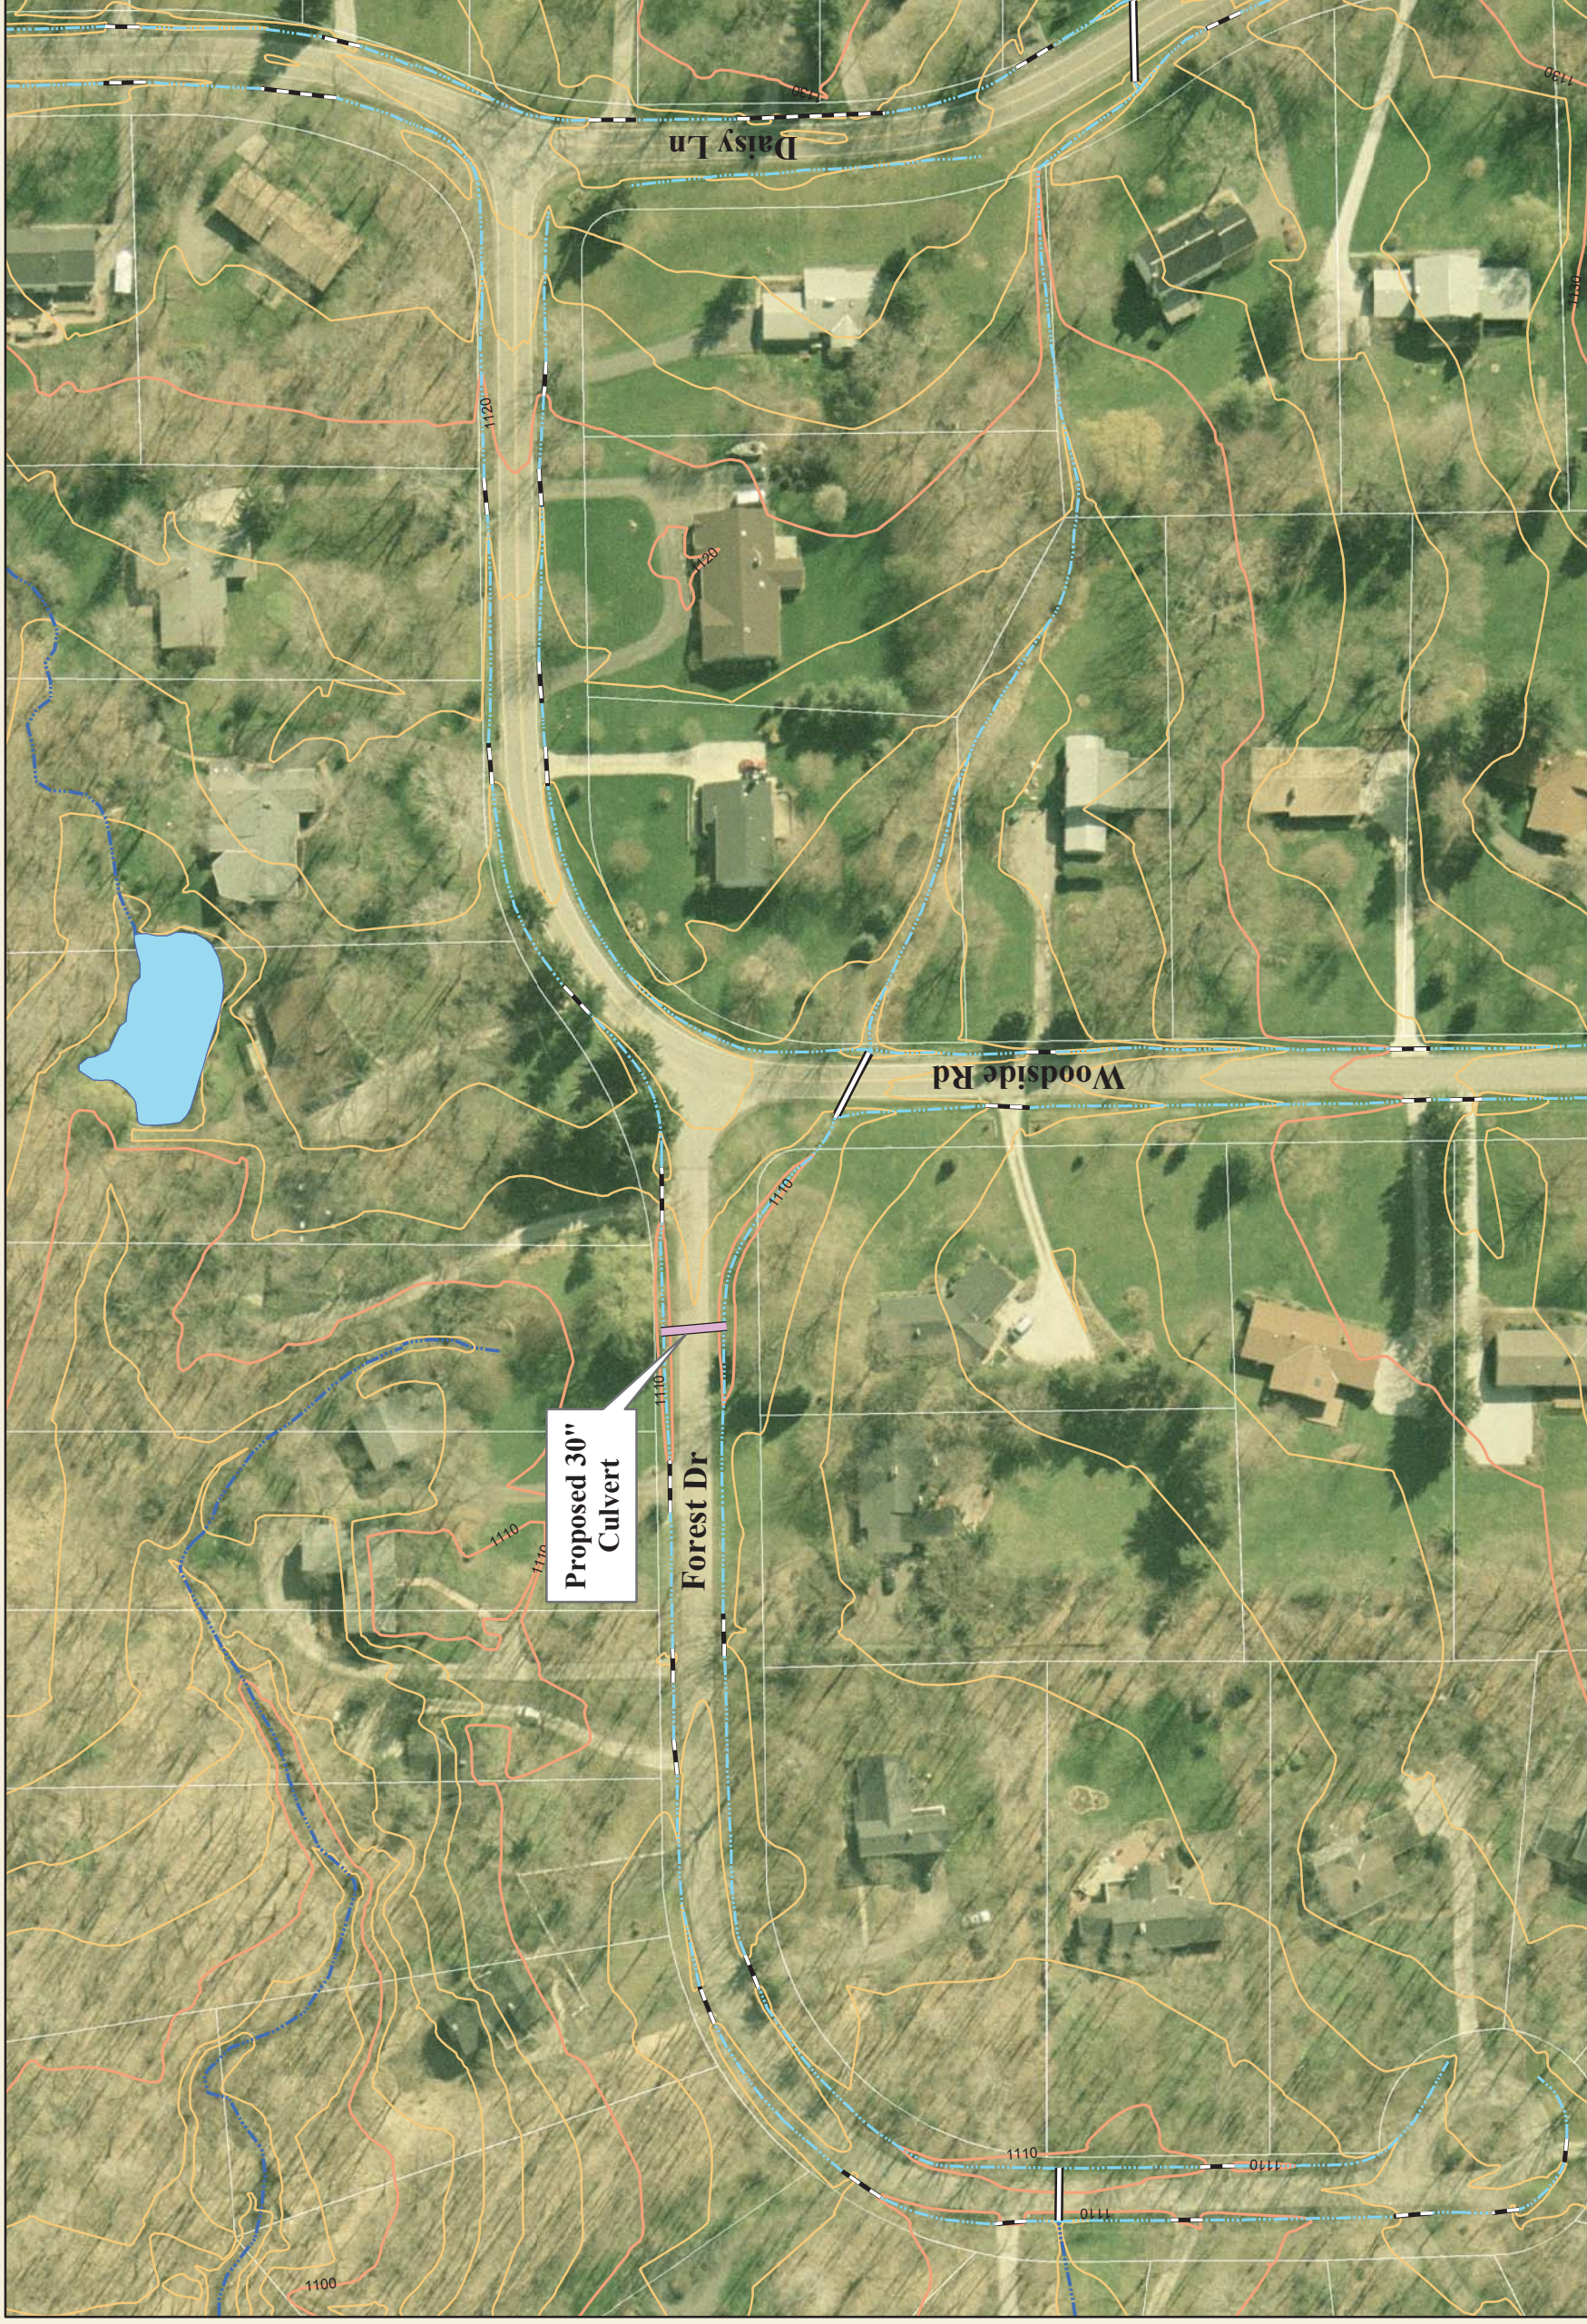
Project Data

Drainage Area = 81 Acre
Peak Flow, 25 Yr = 45 cfs
Existing Capacity = 26 cfs
Estimated Project Cost = \$43,950

The 18” roadway culvert on Woodside Road just south of the Forest Drive intersection, has been found to have the capacity for the peak flow generated by a 2 year storm. This is far less than the 25 year criteria used for roadway culverts.

A possible solution to the problem would be to increase the size of the culvert to pass the calculated peak flow without overtopping the road. This would involve the replacement of the existing culvert with a 30” culvert. Grading easements may be required up and down stream of the work area to perform this work. See **Figure 12** for a drawing of the proposed improvements.

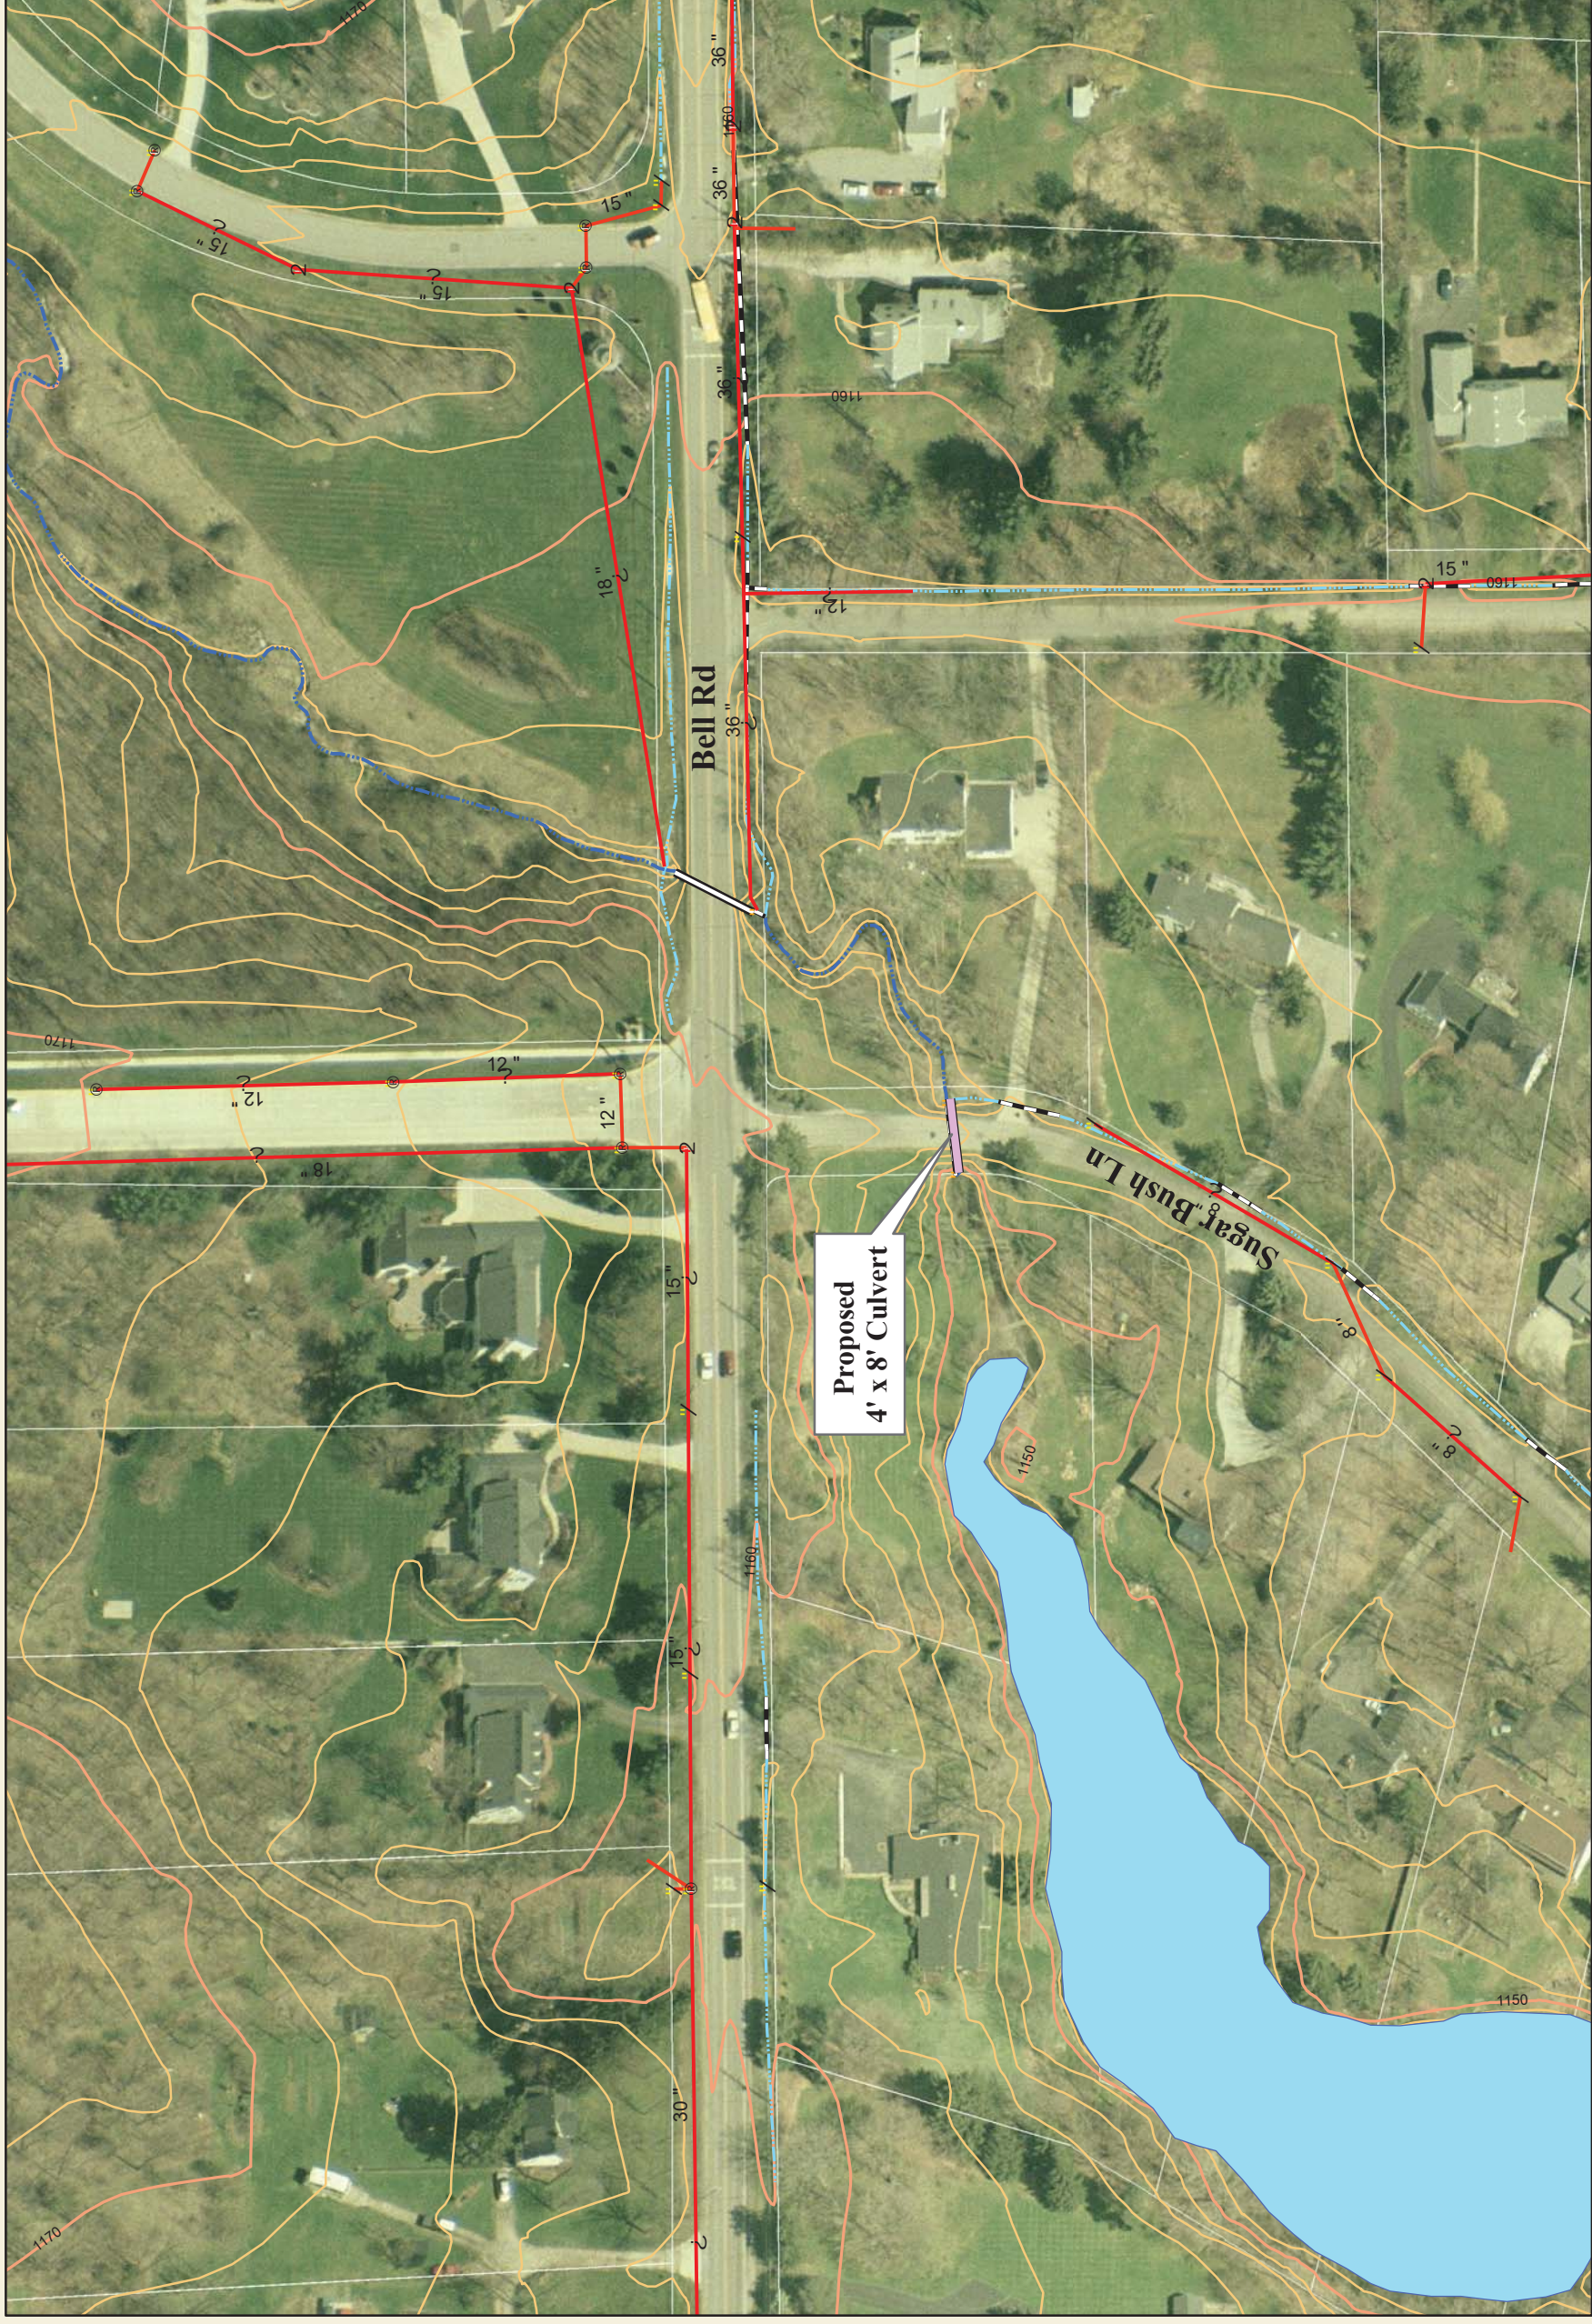
Project Data

Drainage Area = 313 Acre
 Peak Flow, 25 Yr = 245 cfs
 Existing Capacity = 209 cfs
 Estimated Project Cost = \$82,310

The 60” roadway culvert on Sugar Bush Lane, just south of Bell Road has been found to have the capacity of the peak flow generated by a 10 year storm. This is less than the 25 year criteria used for roadway culverts.

Otherwise, the need exists for the culvert to be upsized to a 4’ x 8’ box culvert on the same alignment as the existing culvert. Grading easements may be required up and down stream of the work area to perform this work. See **Figure 14** for a drawing of the proposed improvements.

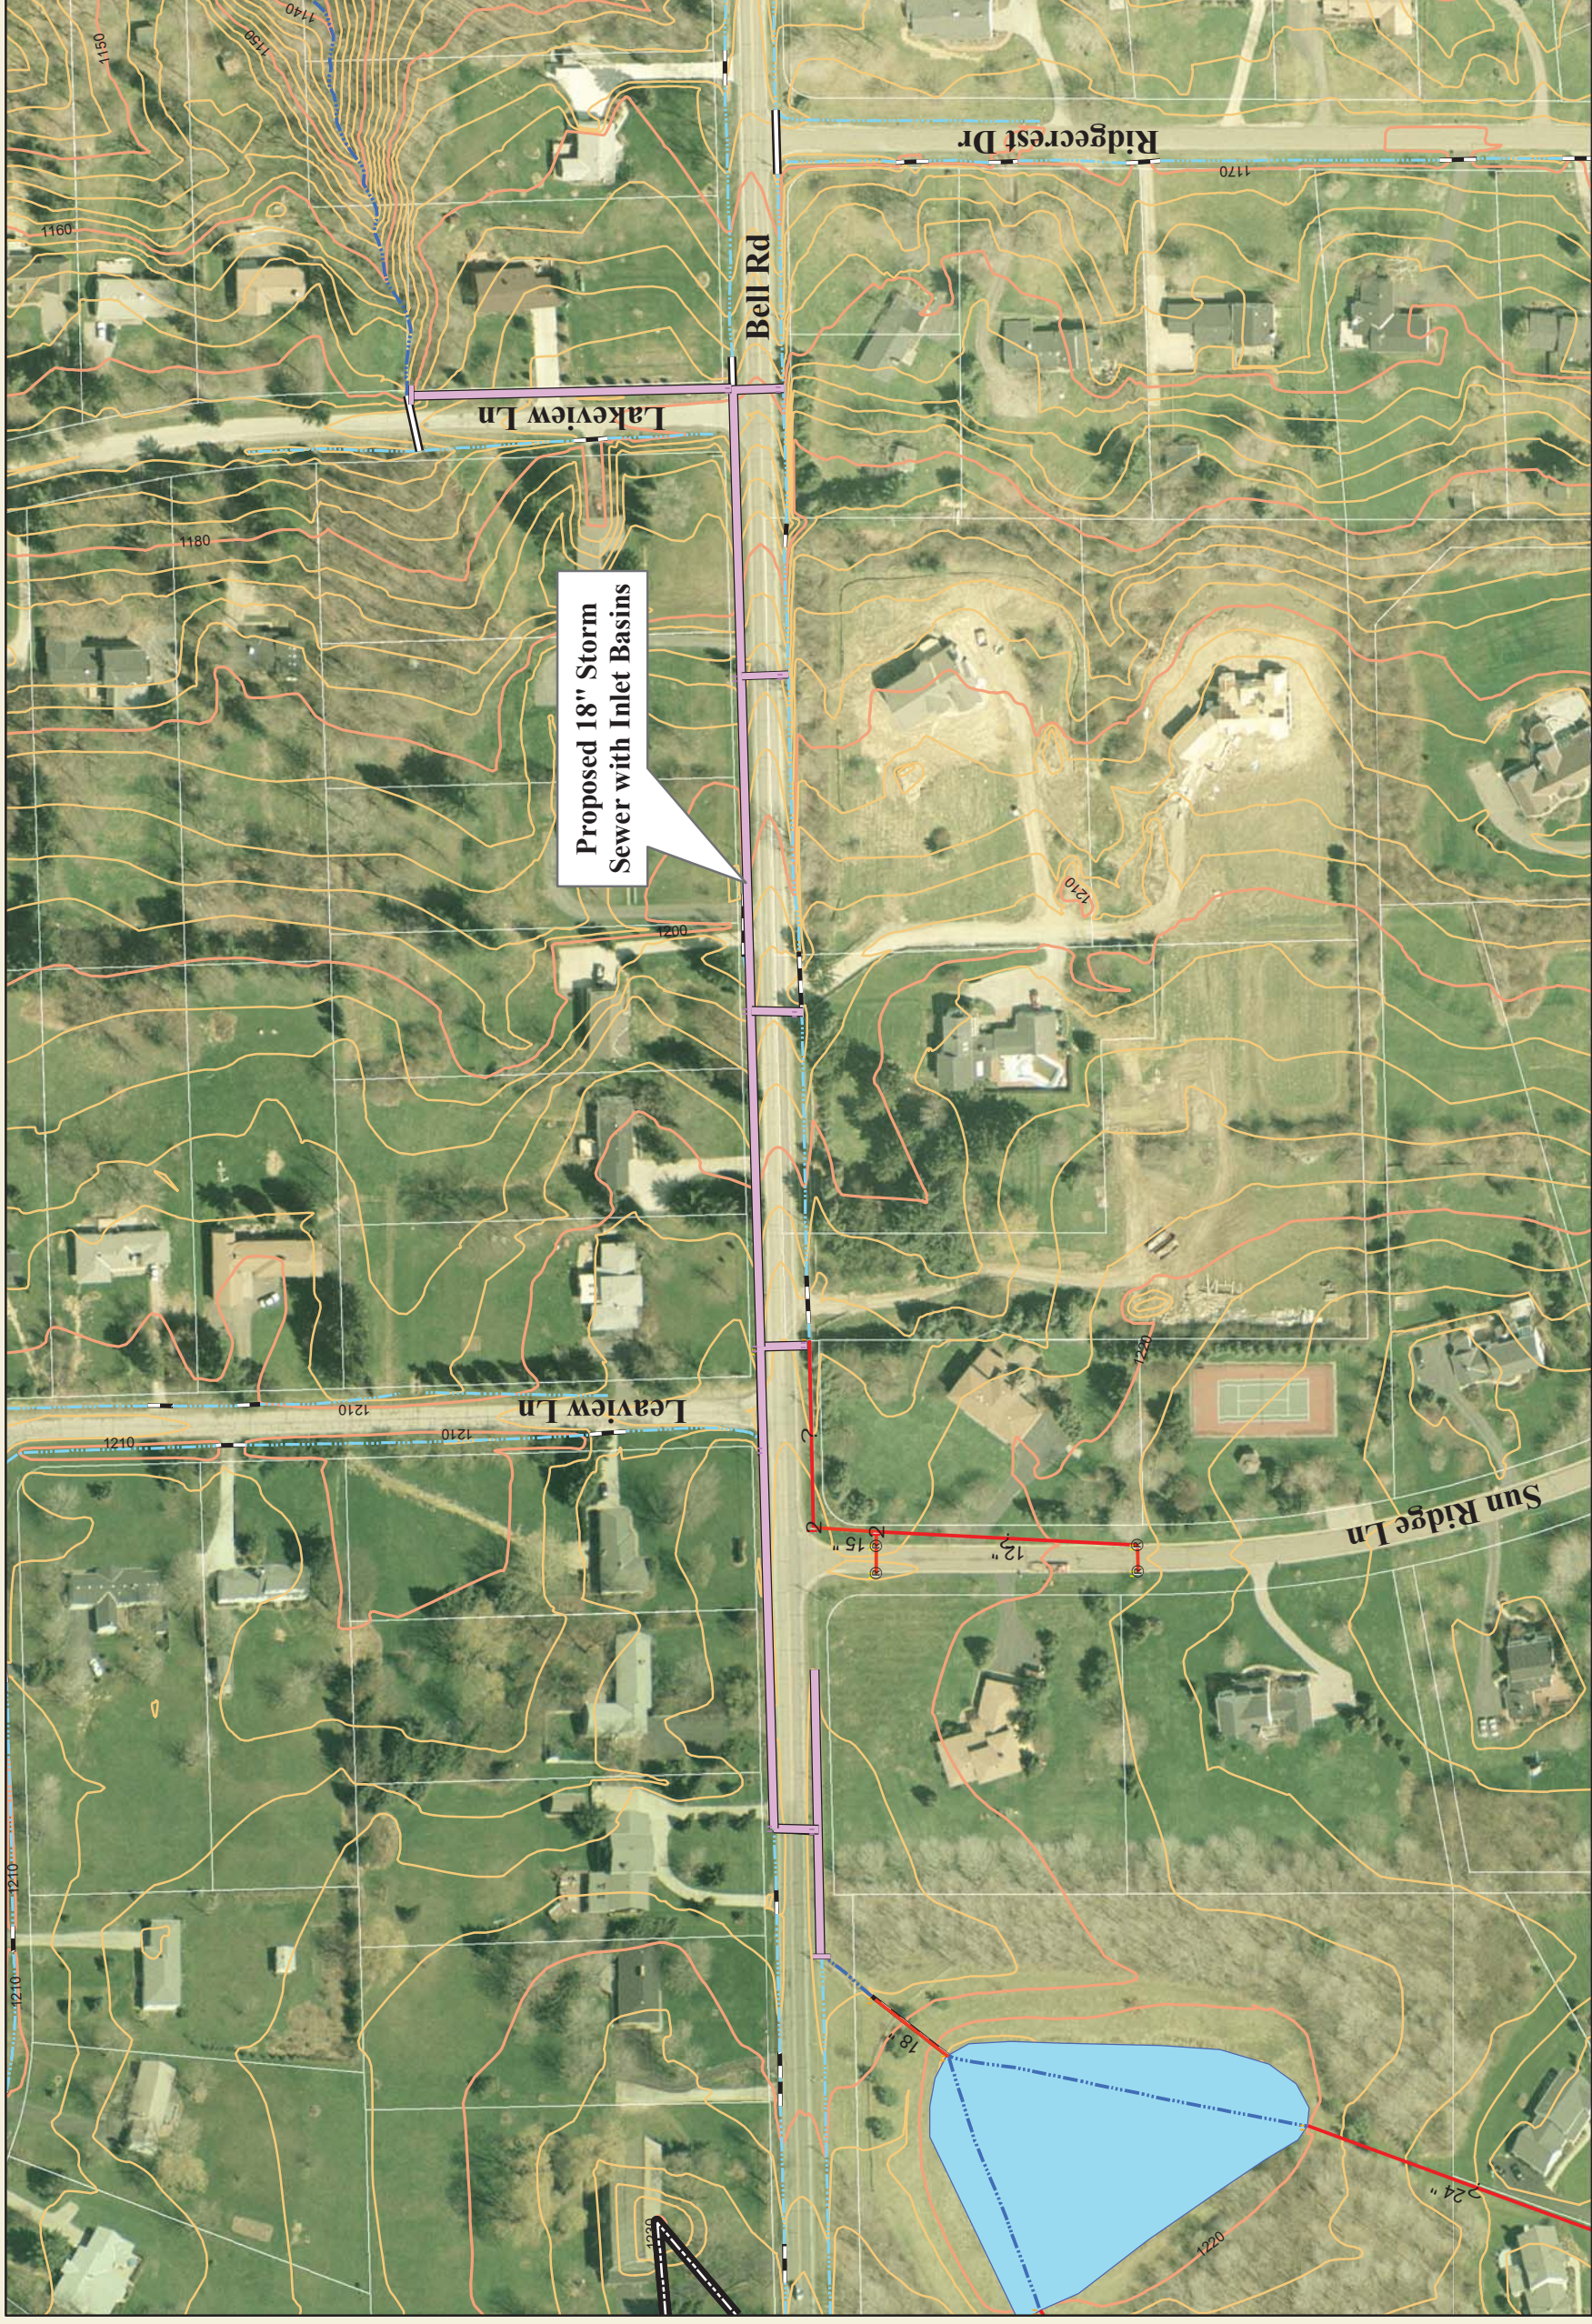
Project Data

Drainage Area = 49 Acre
Peak Flow, 5 Yr = 11 cfs
Existing Capacity = 7 cfs
Estimated Project Cost = \$293,300

The 15” storm sewer along the north side of Bell road from the outlet of the Kensington Greens northeast detention pond to its outlet on Lakeview Lane has been found to have the capacity for the peak flow generated by a storm of less than a 5 year frequency. Although no record of this line has been obtained, its existence was verified by the Street Commissioner. Additionally,

there are areas adjacent to the road where there is poor drainage, and the water is not getting into the existing storm sewer.

A possible solution to this problem would be to replace the existing storm sewer and add inlet basins along both sides of Bell Road. The proposed discharge point would be in the same location on Lakeview Lane. See **Figure 16** for a drawing of the proposed improvements.
